## **URGENT - Field Safety Notice**

### **Medical Device Correction**

#### **Ingenuity CT, IQon Spectral CT, iCT, Brilliance 64 CT, Ingenuity TF, Vereos Step and Shoot Incorrect Image Phase Labeling**

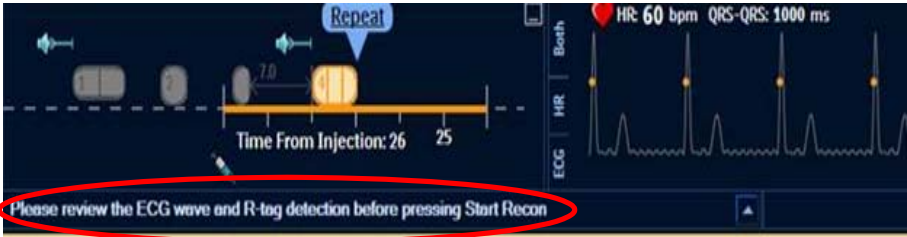
<p>4.x Graphical User Interface example</p> </div> <ul style="list-style-type: none"> <li>How to avoid in 4.x: Wait until the ECG strip is at the top of the acquisition window to starting the reconstruction.</li> </ul>

<p><b>HOW TO IDENTIFY AFFECTED PRODUCTS</b></p>	<p>Determine whether you have a potentially affected system, then determine your AFFECTED PRODUCTS software version.</p> <p>To identify the software version of your product:          Click the "Help" button          Select "About" and the software version is then displayed          Software versions 4.x, 3.x, and 2.x are potentially affected</p>
<p><b>ACTION TO BE TAKEN BY CUSTOMER / USER</b></p>	<ol style="list-style-type: none"> <li>When performing a Step and Shoot acquisition with phase tolerance selected, images may be reconstructed identically (a single phase), but are labeled as different phases. This occurs when "Start Final Recon" is selected prior to display of the ECG wave at the top of the acquisition window.             <ul style="list-style-type: none"> <li>Reconstructed phases display as identical in online reconstruction, but reconstruct correctly during offline reconstruction.</li> <li>This occurs when the user clicks 'Start Final Recon' prior to the Console/Host receiving the ECG wave.</li> </ul> </li> </ol> <div style="text-align: center;">

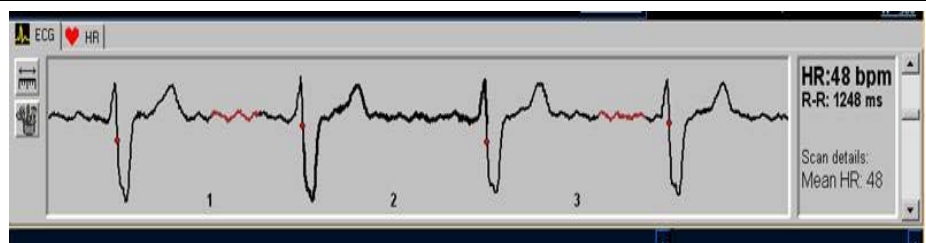
3.x Graphical User Interface example

This issue affects all systems listed above (with the exception of Vereos) with 4.x software and all iCT systems with 3.x software. Images can be reconstructed with phase tolerance by performing an offline reconstruction of the raw data. No patient rescan is required.

- How to avoid in 3.x: Wait until the ECG strip is visible at the bottom of the acquisition window to starting the reconstruction.

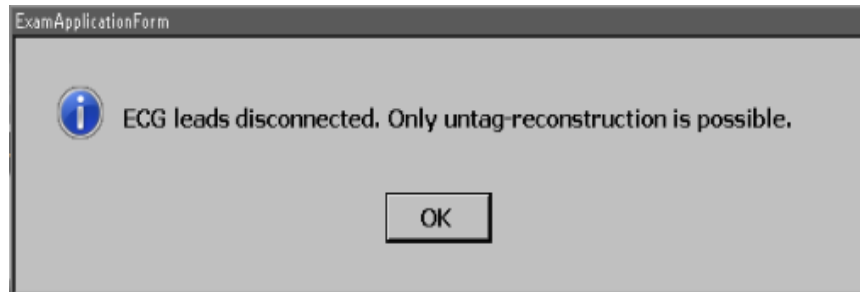
- Should this occur, the user will receive the following console message:

- Images will be incorrectly labeled as if phase tolerance has been applied, however, the images will be reconstructed without phase tolerance.
- How to avoid: Ensure that the leads are securely attached to the patient prior to starting the acquisition and the length of table travel allows the leads to remain securely attached through acquisition completion. In the event of an application crash, there is no way to avoid the issue.
- When this issue occurs, images may still be used but are not labeled with the correct ECG phase. If images with phase tolerance are needed, a rescan may be required.
