**URGENT - Field Safety Notice**  
**Medical Device Correction**  
***Azurion Interventional Fluoroscopic X-ray system***  
***Loosening screws on the C-arm roll motor***

***Azurion Interventional Fluoroscopic X-ray system***

***Loosening screws on the C-arm roll motor***

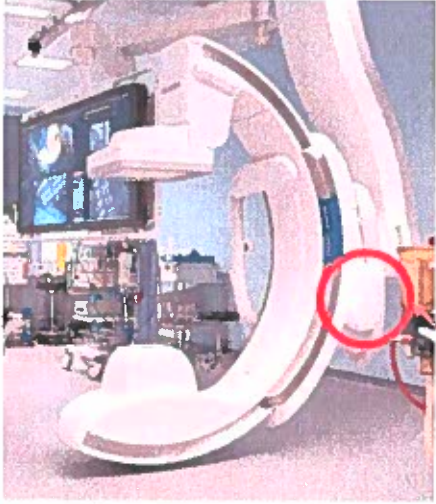
<b>AFFECTED PRODUCTS</b>	Philips Azurion 7 M20 systems distributed between October 2018 and July 2019.
<b>PROBLEM DESCRIPTION</b>	<p>Philips has identified that no torque was specified for the four screws that connect the gearbox and the mounting flange within the C-arm roll motor. If the torque is too low, the movement of the system may lead to stress on the screws, which potentially could result in the four screws becoming loose. If this occurs, the C-arm could rotate freely over the "roll" movement and the system would not be available for use.</p>

<p>The roll motor is under the encircled cover</p>
<b>HAZARD INVOLVED</b>	<p>If the four screws of the C-arm roll motor assembly become totally loose, the C-arm could rotate freely over the "roll" movement. The system would not be available for use and there could be a delay of the treatment. An uncontrolled movement of the C-arm could result in collision and/or entrapment.</p>

<b>ACTIONS PLANNED BY PHILIPS</b>	Philips will exchange the roll motor in all affected systems, free of charge. This action will start in March 2020. You will be contacted by our local Philips representative to schedule an appointment to replace the roll motor.
<b>FURTHER INFORMATION AND SUPPORT</b>	If you need any further information or support concerning this issue, please contact your local Philips representative.
