FSN MA FCO-72000015 2020-Feb-17

URGENT - Field Safety Notice ***TraumaDiagnost***

Check of integrity for Trauma Arm

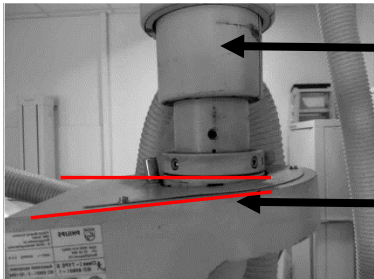
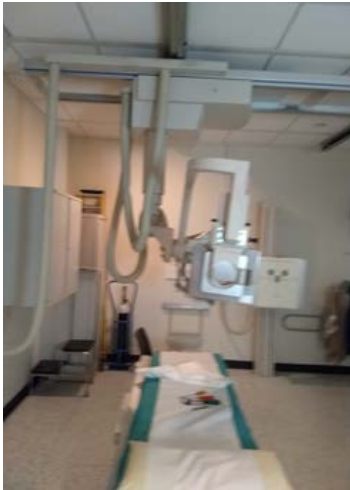
HOW TO IDENTIFY AFFECTED PRODUCTS	<p>An operator noticed an unusual angle of the trauma arm with respect to the telescopic column of the ceiling suspension.</p> <div style="display: flex; align-items: center;">

<div style="margin-left: 10px;"> <p>Telescopic column of ceiling suspension</p> <p>Supporting block</p> </div> </div>

ACTION TO BE TAKEN BY CUSTOMER / USER	<p>The IfU (Instruction for Use) require the operator to not use the system and call for service, if a mechanical defect or malfunction is suspected.</p> <p>As soon as a deformation is determined, the system may no longer be used and call the service engineer.</p> <p>Should you feel uncertain regarding these instructions, please contact Philips.</p>
ACTIONS PLANNED BY PHILIPS	<p>The affected systems will be get an onsite check of the status of the Trauma arm for deformations as shown on the pictures.</p>
FURTHER INFORMATION AND SUPPORT	<p>If you would like any further information or support concerning this issue, please contact your local Philips representative.</p>
