## **URGENT – Field Safety Notice Zenition 50 and Zenition 70**

Loss of strain relief in the interconnecting cable between the Mobile Viewing Station and the C-arm Stand  
(Stand MVS Trolley Cable)

FSN 2020-IGTPUN-004

09-APR-2020

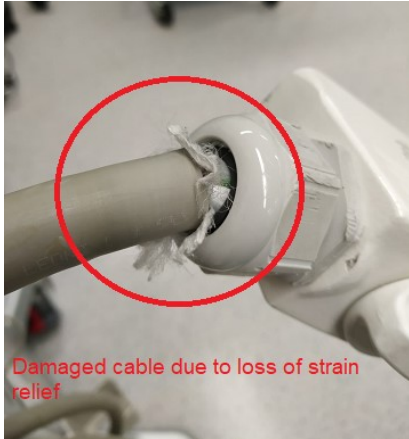
<b>AFFECTED PRODUCTS</b>	29 systems of the models Zenition 50 (Product Code: 718096) and Zenition 70 (Product Code: 718133).
<b>PROBLEM DESCRIPTION</b>	<p>The affected systems contain a Stand MVS Trolley Cable (the interconnecting cable between the Mobile Viewing Station and the C-arm Stand) where the strain relief at the stand side may fail. When the strain relief is lost, over time one or more electrical contacts could break due to pulling, twisting or dropping of the connector. If this happens, live parts may be exposed (230 V) and/or the video signal can be lost.</p>

<p>Damaged cable due to loss of strain relief</p>
<b>HAZARD INVOLVED</b>	<p>In the event of strain relief loss, the following are potential hazards:</p> <ul style="list-style-type: none"><li>• Electric shock if a live part is touched (230V)</li><li>• Delay in treatment due to interruption of procedure or system not being available when needed.</li></ul>

<ul style="list-style-type: none"><li>○ Please ensure that all staff working with the system are informed of the content of this safety notice and place a copy of it with the Instructions for Use.</li></ul>
<b>ACTIONS PLANNED BY PHILIPS</b>	Philips will be replacing the Stand MVS Trolley Cable (459800943703) in all affected systems by a new Stand MVS Trolley Cable that has an improved strain relief design. This action will start by end of April 2020. You will be contacted by our local Philips representative to schedule an appointment to replace the cable.
<b>FURTHER INFORMATION AND SUPPORT</b>	If you need any further information or support concerning this issue, please contact your local Philips representative:

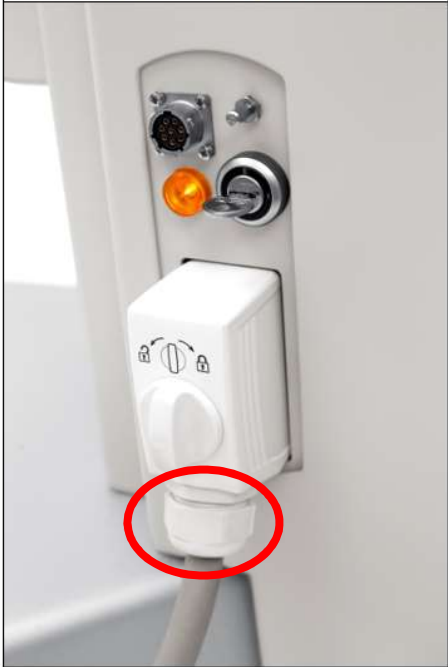
<div><div><h4>Affected Systems</h4>

<b>HOW TO IDENTIFY AFFECTED PRODUCTS</b>	<p>Affected systems contain the cable 459800943703 (Stand MVS Trolley Cable).</p> <p>Users can identify if their Zenition 50 (Product Code: 718096) and Zenition 70 (Product Code: 718133) contain this cable by checking the plastic nut of the cable.</p>
