syngo.via RT Image Suite
with syngo.via VB30 and syngo.via VB40 software

Customer Safety Advisory Notice SY038/20/S

Subject: Potential incorrect geometry in resulting Synthetic CT images created by the software option “Synthetic CT” of syngo.via RT Image Suite when using input MR images

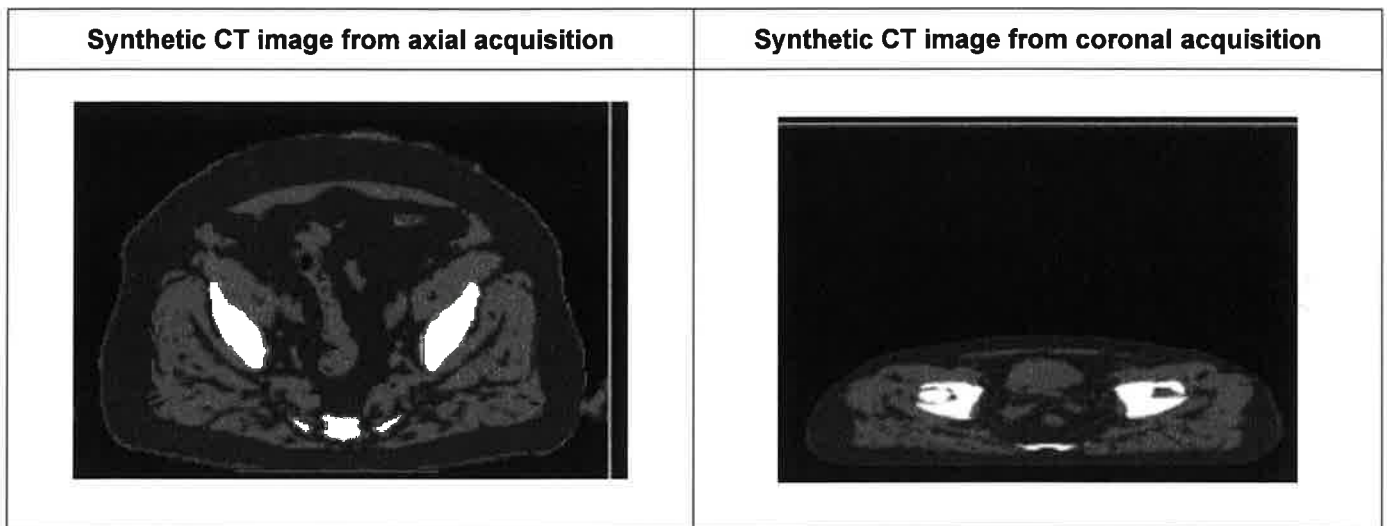
If the user modifies for any reason (e.g. reduction of artifacts) the original image orientation of a standard MR protocol to acquire images in a different orientation for further processing in “Synthetic CT”, the software does not recognize the adapted acquisition plane. This may result in images with wrong geometry. When this distortion remains unnoticed and the images are subsequently exported to a treatment planning system (TPS), an incorrect calculated radiation treatment plan cannot be excluded. The occurrence of this case is very unlikely and has never been reported so far.

An example of a visibly distorted image is shown in Fig. 1 (next page).

Fig. 1: Comparison of Synthetic CT image calculated from axial acquisition to Synthetic CT image calculated from coronal direction.

1. Use MR data acquired in axial orientation as input for Synthetic CT calculation only.
2. Use protocols validated by Siemens Healthineers only.
3. In any case, perform a pretreatment verification to compare the actual treatment position with the target position.

The described issue will be solved with a service pack for software versions *syngo.via* VB30 and *syngo.via* VB40. Depending on your current software version, the service pack VB30A_HF08 will be installed with update SY039/20/S or the service pack VB40B_HF01 with update SY040/20/S as soon as it is available.
