E-mail	advancedtherapies-fsca.team@siemens-healthineers.com
Date	July, 2020
Corrective Action ID	AX048/20/S

## **Customer Safety Advisory Notice (CSAN) for Field Safety Corrective Action:**

**Subject: Sensis Vibe Hemo systems with MicroPod™ EtCO<sub>2</sub>**

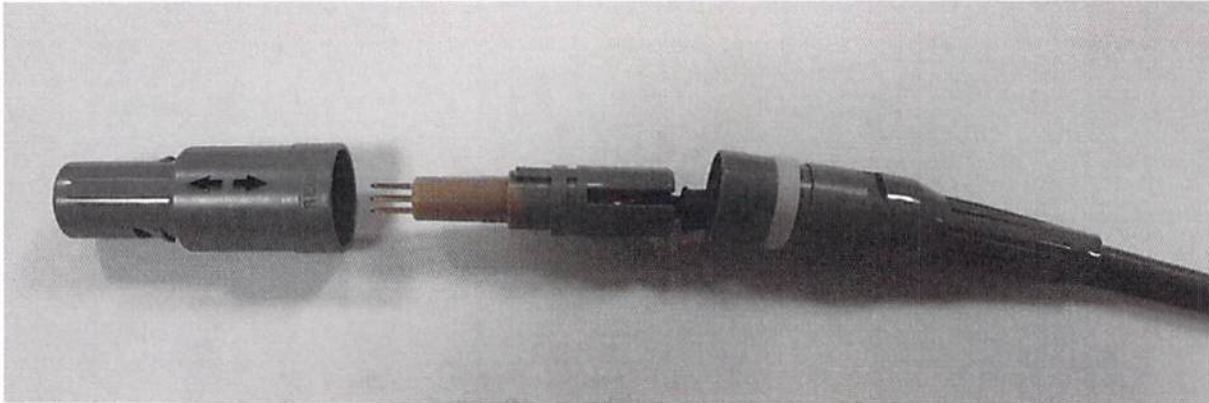
The connector joining the EtCO<sub>2</sub> module to the HemoBox may break and become damaged (see Figure 1). The damage to the connector may occur under certain conditions that place strain or unexpected force on the cable and/or connector. Examples include (but are not limited to) stretching of the cable due to table movement, collision of the connector with other equipment, or incorrect plugging/unplugging of the connector. If the connector is re-connected to the HemoBox in this damaged state, the contact pins may not be in the proper alignment.

Figure 1: Example of broken connector

If the connector is re-connected to the HemoBox in this damaged state, under certain incorrect pin alignment conditions, the HemoBox may stop functioning and all vital signs are lost until the EtCO<sub>2</sub> module is disconnected. When the module is not connected, EtCO<sub>2</sub> monitoring is not available.

The problem was identified by regular field observation. The root cause is due to missing requirements in the connector assembly process.

If the connector joining the EtCO<sub>2</sub> module to the HemoBox should become damaged or break, the operator shall not attempt to fix the connector or re-connect the cable to the HemoBox. Only Siemens Healthineers' Customer Service or a service provider authorized by Siemens Healthineers may resolve the issue.

We are currently working on a solution to eliminate the root cause of this problem. As soon as a solution is available, our service organization will get in contact with you to schedule the corrective action.
