**syngo.via RT Image Suite**  
with *syngo.via* VB30 and *syngo.via* VB40 software  
with licence for patient marking with external lasers  
(technical name of the license:  
"CT RT IMAGE SUITE PAT MARK")

Customer Safety Advisory Notice SY051/20/S

**SOMATOM go. CT Scanners with  
syngo.RT Image Suite**  
with *syngo*.CT VA20A, *syngo*.CT VA30A  
with licence for patient marking with external lasers  
(technical name of the license:  
"CT RT IMAGE SUITE PAT MARK")

**Subject: Incorrect calibration offset between CT central image plane and external lasers after update/upgrade potentially resulting in an unprecise cancer treatment**

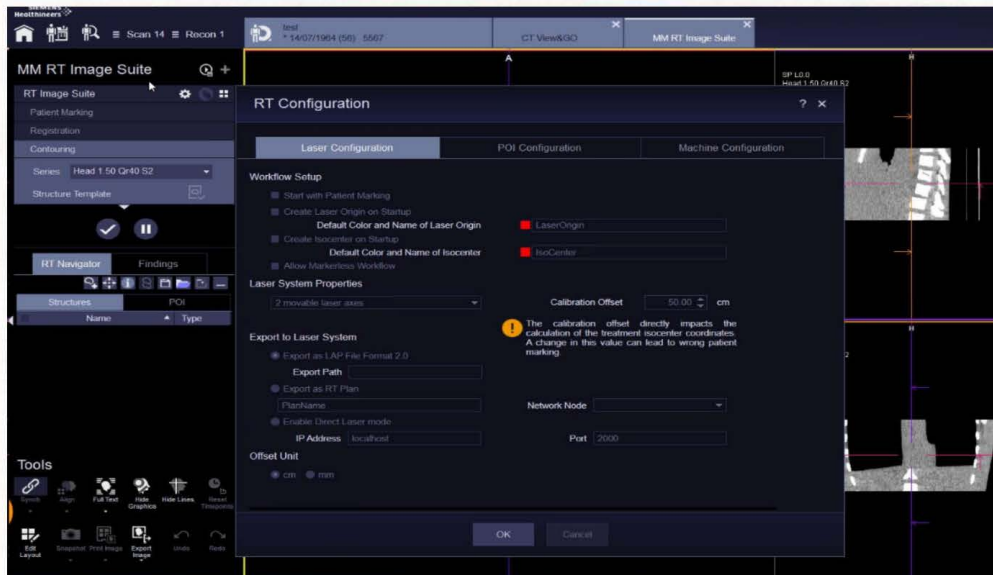
The calibration offset between the central CT image plane and the external RT lasers has been set automatically to the factory default of 50.00 cm, if your *syngo.via* RT Image Suite has been updated or upgraded to one of the following software versions:  
- *syngo*.CT VA20A to *syngo*.CT VA30A  
- from any lower *syngo.via* SW-version to *syngo.via* VB40

Figure 2: MM RT Image Suite Configuration dialog with the marked parameter

Please update the calibration offset in the MM RT Image Suite Configuration dialog accordingly as shown below in Figure 2. Details of this procedure are documented in Chapter 13.2 (Laser configuration) of your user manual.
