Customer Safety Advisory Notice

CAN 001-2020

Re: **Symbia S and Symbia T system unintended detector motion**

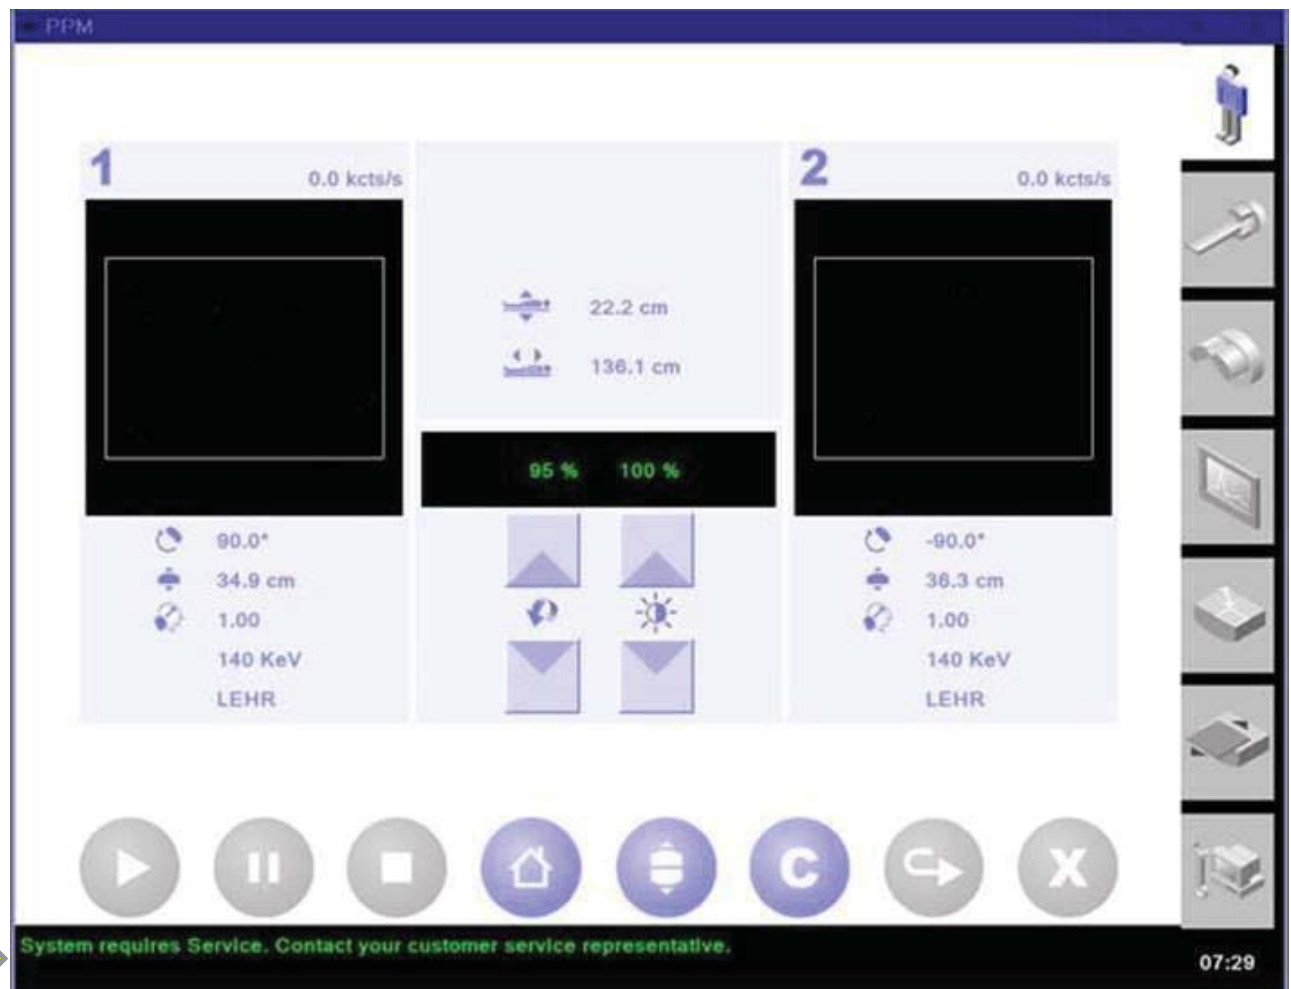
If unintended detector motion is observed, downward pressure from the detector is reported by the patient at any time or the PPM presents a system error (as shown in the picture below), then manually retract the patient from the gantry using the patient bed handle and release button, stop use of the system and contact your customer service representative.
