## Urgent Field Safety Notice

### O-arm™ O2 Imaging System

January 2020

Medtronic reference: FA895 Phase II

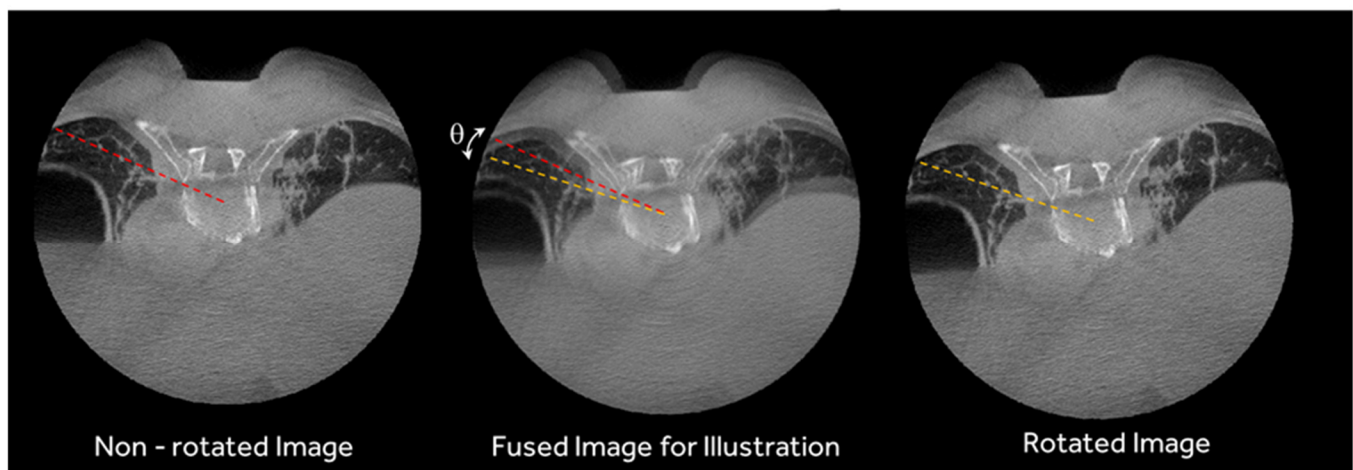
Medtronic has determined through internal testing that there is a potential for navigational inaccuracy when utilizing the O-arm™ O2 Imaging System's auto-registration feature, when used in conjunction with an Image-Guided Surgery System, for a specific set of O-arm™ O2 Imaging System serial numbers. A list of potentially affected systems is provided in Table 1 of this letter. Due to loosening of an internal motor drive belt over an extended number of uses,

image rotation may occur relative to patient positioning data. Inaccuracy may occur when the O-arm registration information is transferred to an Image-Guided Surgery System to be used in navigation, utilizing the rotated images.

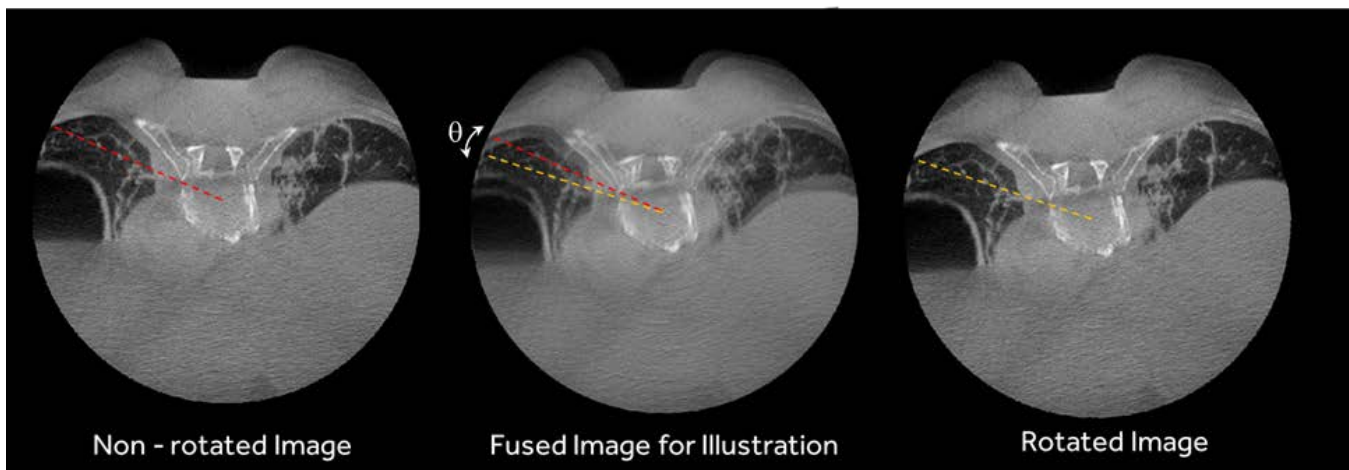
Medtronic has determined through internal testing that there is a potential for navigational inaccuracy when utilizing the O-arm™ O2 Imaging System's auto-registration feature, when used in conjunction with an Image-Guided Surgery System for a specific set of O-arm™ O2 Imaging System serial numbers. A list of potentially affected systems is provided in Table 1 of this letter. Due to loosening of an internal motor drive belt over extended number of uses, image rotation may occur relative to patient positioning data. Inaccuracy may occur when the O-arm registration information is transferred to an Image-Guided Surgery System to be used in navigation, utilizing the rotated images.
