**syngo.via RT Image Suite**  
with *syngo.via* VB30, VB40, VB50 and VB60

Customer Safety Advisory Notice SY052/21/S

**Subject: Potential loss of unsaved results when using *syngo.via* RT Image Suite**

Customer Safety Advisory Notice MR019/21/S

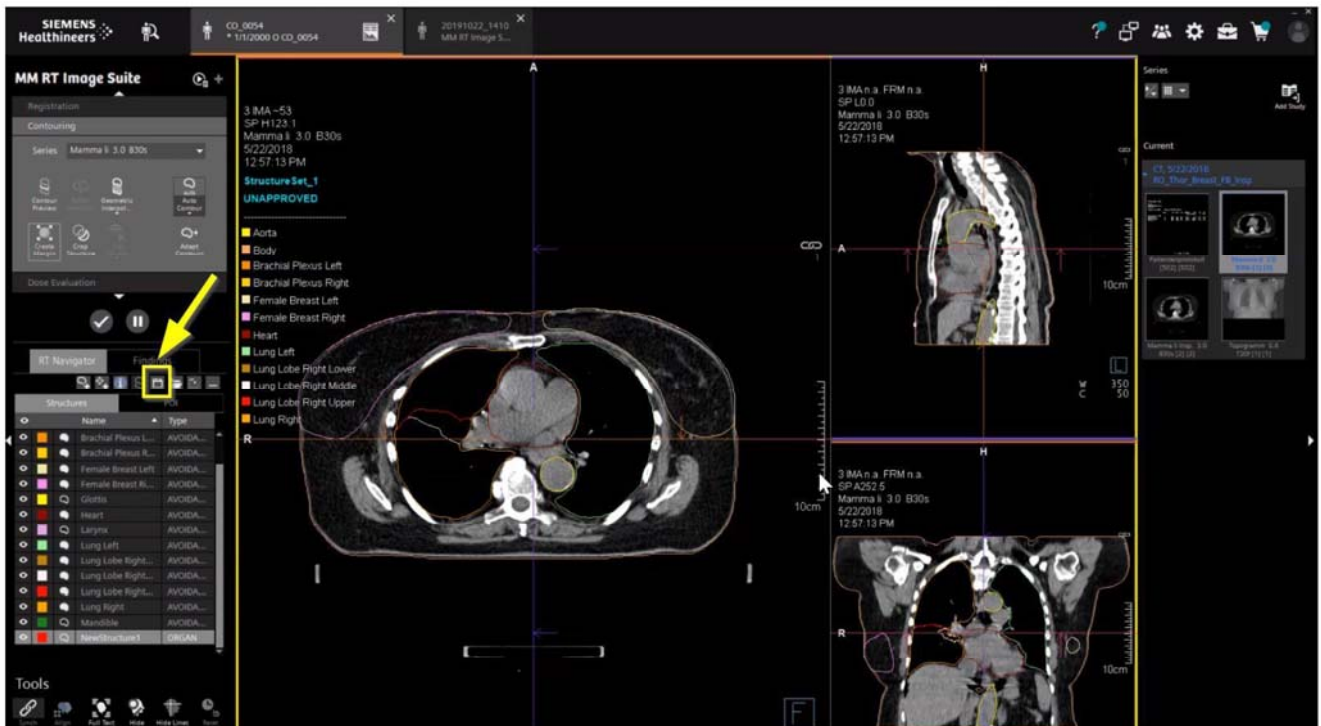
The following technical issue has been identified in a user scenario, when a structure set has already been saved in *syngo.via* RT Image Suite and is then saved again after further edits:  
The workflow is marked as completed, but sporadically the RT structure set might not have been saved into the local database.

**Figure 1: Save Structure Set from RT Navigator (screenshot taken from *syngo.via* VB60)**

For *syngo.via* VB50 and *syngo.via* VB60, the following workaround is available: before clicking “complete”, save the data using the RT navigator “Save” button (see Figure 1).

Note for *syngo.via* VB50: this workaround might result in two structure sets in the patient browser. Please check the latest timestamp to identify the most recent structure set to be sent to the archive (PACS) or your treatment planning system (TPS).

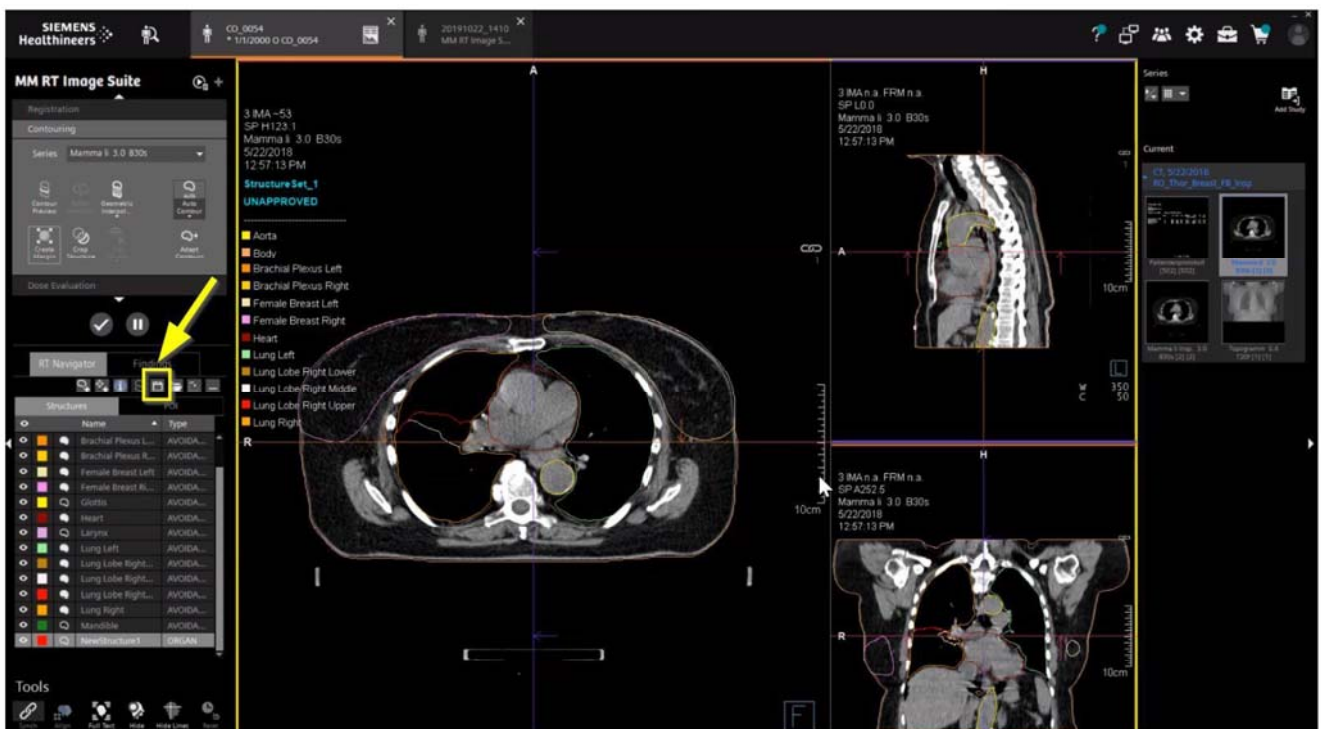
The following technical issue has been identified in a user scenario, when a structure set has already been saved in *syngo.via* RT Image Suite and is then saved again after further edits: The workflow is marked as completed, but sporadically the RT structure set might not have been saved into the local database.

**Figure 1: Save Structure Set from RT Navigator (screenshot taken from syngo.via VB60)**

For affected scanners running on software versions syngo MR VA30A and VA31A, the following workaround is available: before clicking “complete”, save the data using the RT navigator “Save” button (see Figure 1).

Note for affected scanners running on software versions syngo MR VA30A and VA31A: This workaround might result in two structure sets in the patient browser. Please check the latest timestamp to identify the most recent structure set to be sent to the archive (PACS) or your treatment planning system (TPS).

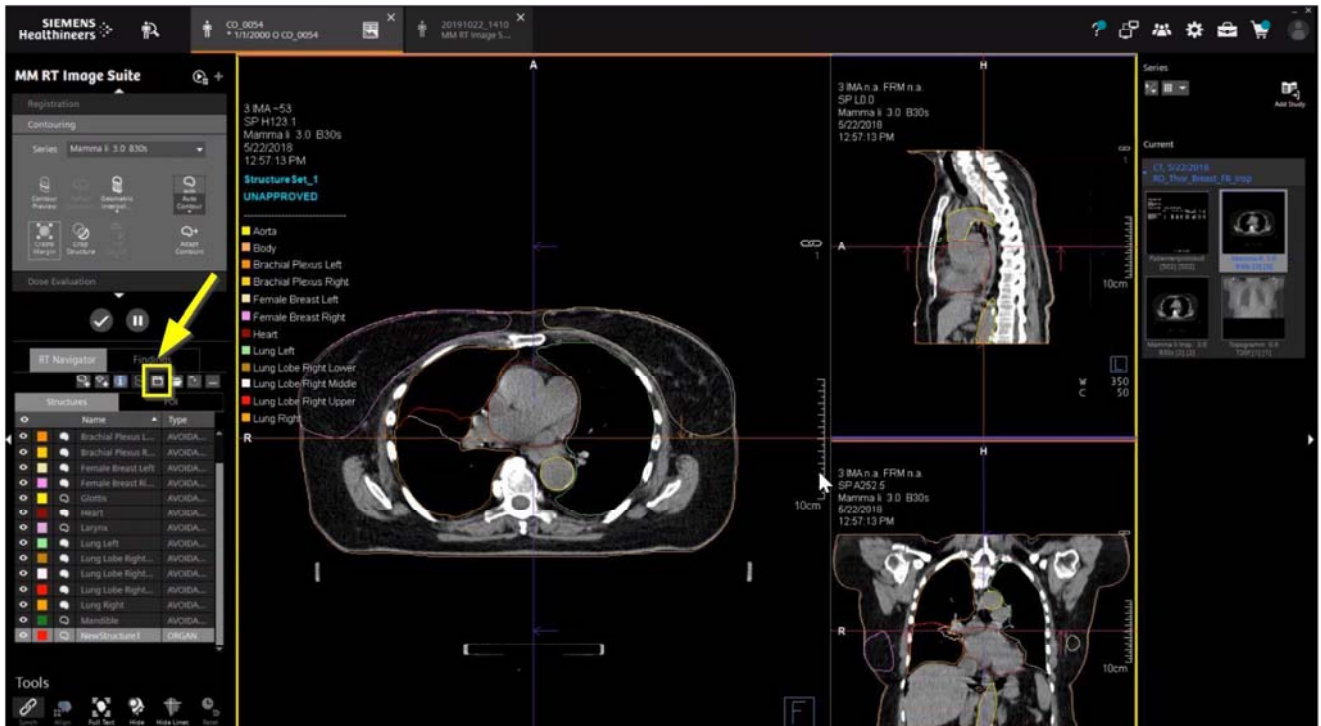
The following technical issue has been identified in a user scenario, when a structure set has already been saved in *syngo.via RT Image Suite / Sim&GO* and is then saved again after further edits: The workflow is marked as completed, but sporadically the RT structure set might not have been saved into the local database.

**Figure 1: Save Structure Set from RT Navigator (screenshot taken from *syngo* CT VA40A)**

For affected scanners running on software version *syngo* CT VA40A, the following workaround is available: before clicking “complete”, save the data using the RT navigator “Save” button (see Figure 1).
