URGENT Field Safety Notice

MultiDiagnost Eleva

MultiDiagnost Eleva intermittently does not load license files

17-Dec-2021

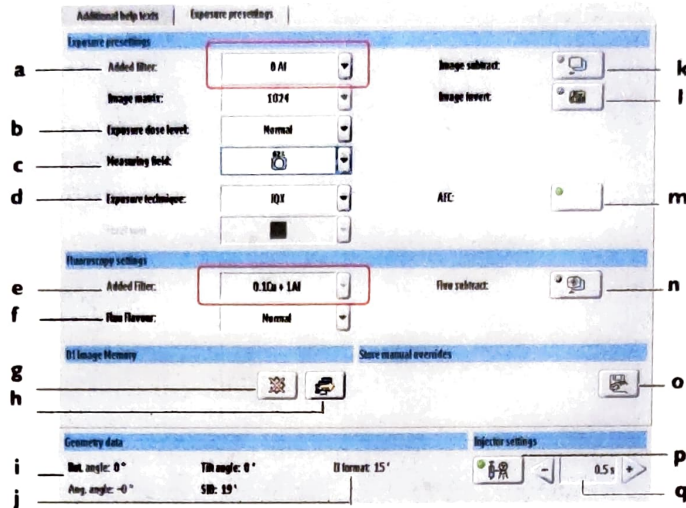
- The License Key for Spectral Filter. Within the MD-Eleva system the spectral filter is used to ensure that the low mode for Reference Air Kerma Rate does not exceed 50% of the value for the normal mode. When the license file is not loaded, the low mode for Reference Air Kerma Rate will not be reduced to 50% of the value for the normal mode but reduction will be lower resulting in approximately 70-80% of the value for the normal mode.

The actual filter selection is displayed on the "Exposure presettings" tab of the examination monitor in the in the control room as shown in Figure 1:

- item "a" indicates the exposure setting
- item "e" indicates the fluoroscopy setting.

If Item "a" can be changed manually, the License Key for Spectral Filter is correctly loaded. If item "a" cannot be changed manually, the License Key for Spectral Filter is not correctly loaded.

Figure 1: Exposure setting is indicated by “a” on the "Exposure presettings" tab on the Examination Console in the Control Room

- The License Key for Spectral Filter: Confirm that the License Key for Spectral Filter is correctly loaded after system start up by checking the exposure setting on the "Exposure presets" tab on the examination monitor in the Control Room. If the License Key for Spectral Filter is not correctly loaded, perform a system restart. If the restart does not solve the problem, perform another restart.

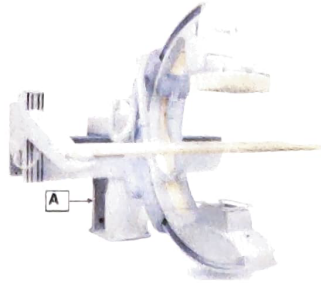
The system product name and model number can be found in the System Basic Label located on the back side of the stand as shown in Figure 2. The software version of the MultiDiagnost Eleva system can be identified during the start-up. If the system has software version R6.1.1sp2 or R6.1.2. installed, it is affected by the problem.

Figure 2: "A" shows the location of the System Basic Label
