**FIELD SAFETY NOTICE**

**Philips StentBoost Live R2.0 application  
X-ray images might not be processed**

2022-Feb-02

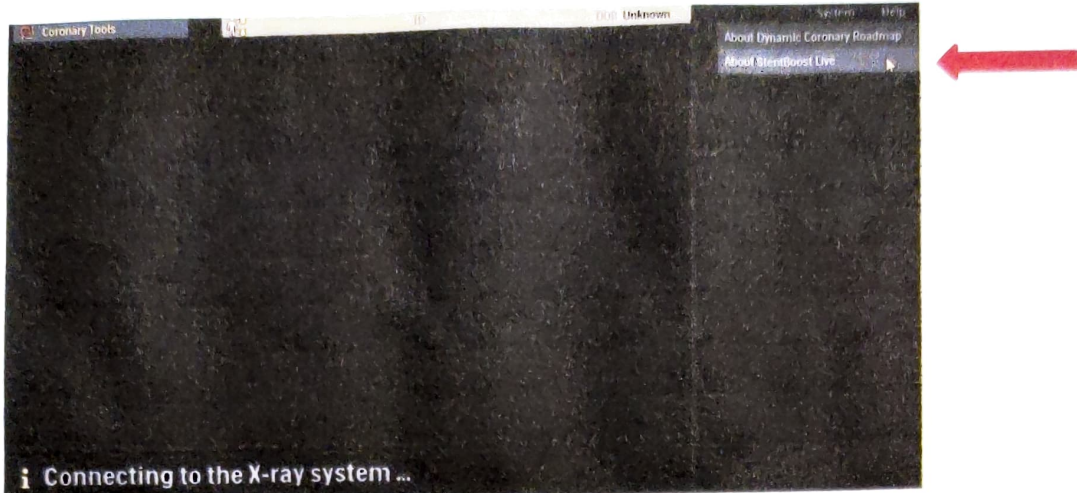
Fig. 1: Location of the “About” box in the user interface.

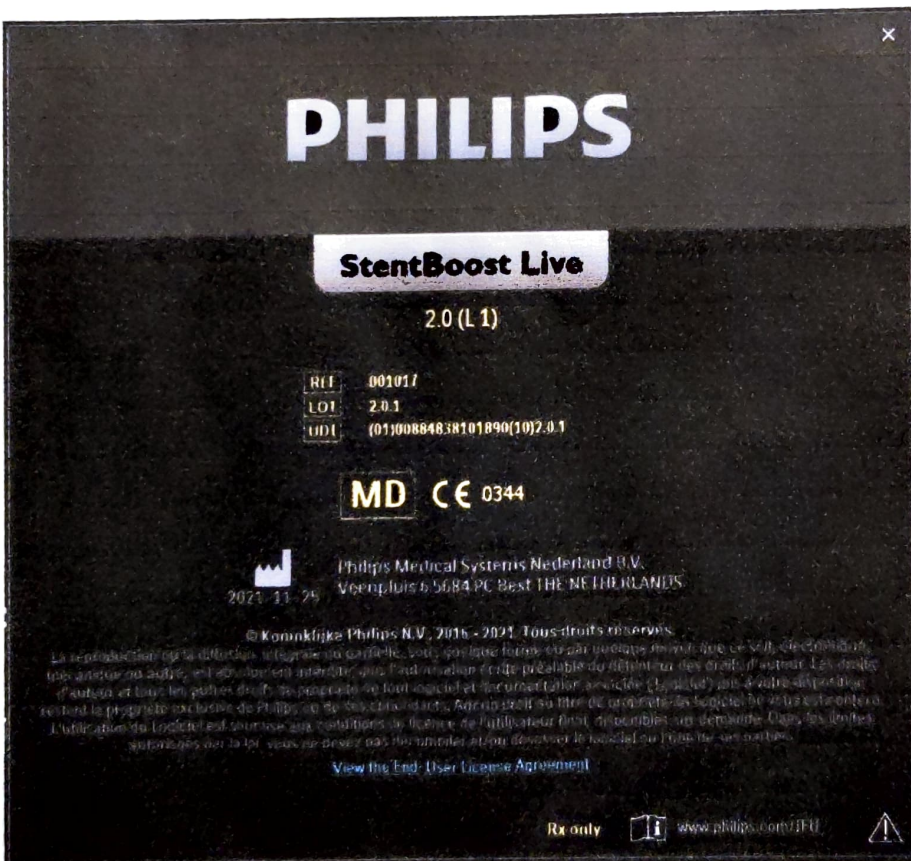
Fig. 2: Software version of StentBoost Live.
