**Field Safety Notice**

**Philips Azurion R2.0.x System  
Inadvertent change of Patient Type when the study starts**

2022-Feb-08

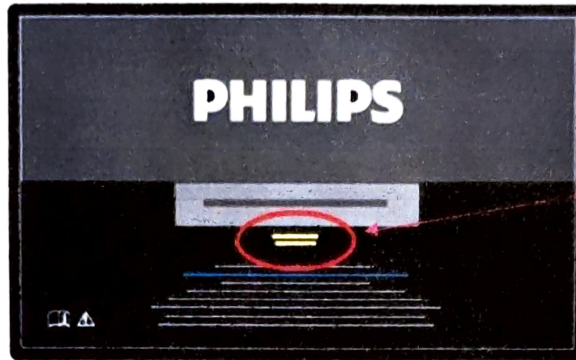
Fig. 2: Start-up screen

The software version of the Philips Azurion system is displayed during the start-up of the system (Fig. 2).

Software Version
