| Product/Trade Name: | ARTIS icono biplane, ARTIS icono floor, ARTIS pheno | EU-SRN | DE-MF-000006122 |
| | | Corrective Action ID | AX003/22/S, AX004/22/S |

Customer Safety Information (CSI) for Field Safety Corrective Action

Subject: Software update of ARTIS systems with software version VE20 to VE21

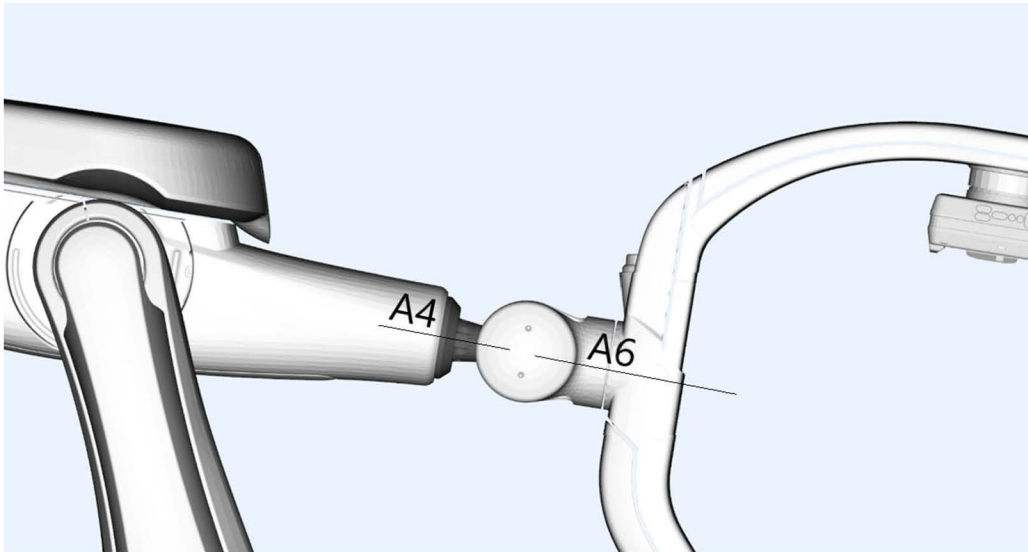
Figure 1: C-Arm position in singularity

In special, clinically untypical positions of the ARTIS pheno stand (see figure 1) the robot may move into a so called singularity position, where the movement may get stopped and blocked.

If this issue occurs, all stand movements are blocked and can only be reactivated by a field service engineer. Depending on the status of the intervention, the limited functionality may not be sufficient to continue with treatment as planned. This may result in a situation where it is necessary to cancel clinical treatment or to continue treatment on an alternative system.

The issue has been identified in the field in combination with a suboptimal system adjustment only. The root cause for the blocked stand movement is a software issue.

Please consider the need to establish emergency procedures to manage situations related with the failure of your ARTIS system according to the User Manual.

The software will be updated.
