**syngo.via RT Image Suite running on servers with syngo.via VB60 software after upgrade CT scanners with syngo.CT VA40A after upgrade**

Customer Safety Advisory Notice CT004/22/S

**Subject: Silent change of default Patient Marking workflow setting after upgrading to new RT Image Suite version with syngo.via VB60 or syngo.CT VA40 software**

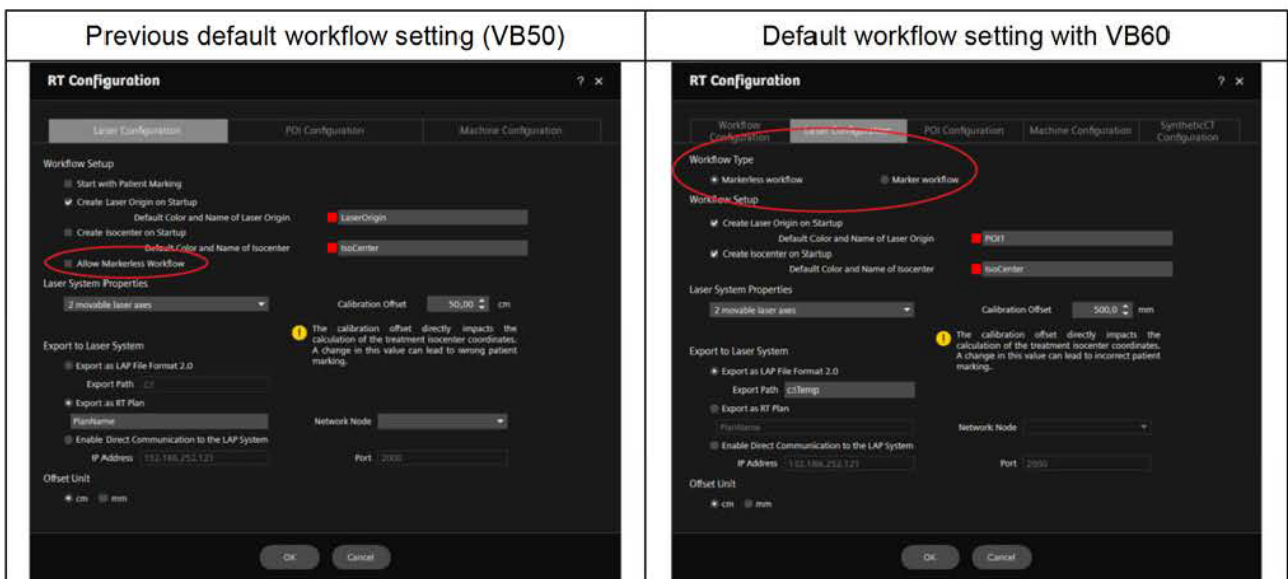
In RT Image Suite versions prior to syngo.via VB60 / syngo.CT VA40, the Workflow Setup “Allow Markerless Workflow” was deactivated by default in the Laser Configuration settings (c.f. fig.1 below, left column). After upgrading RT Image Suite to VB60, this setting is automatically, and without explicit notification, changed to “Markerless workflow” in the new “Workflow Type” section in the Laser Configuration settings with VB60 (c.f. fig. 1 below, right column).

Fig. 1: Comparison of default workflow setting in VB60 and previous versions (example: VB50).

If a marker-based workflow was used prior to the upgrade, then following the upgrade the laser offset coordinates in the Patient Marking step are no longer calculated based on the marker position. If the radiopaque markers are not placed at the laser zero position as described in the "Instructions for Use" (IFU), this may lead to the wrong laser offset coordinates being displayed in the Patient Marking step.

After upgrading RT Image Suite to VB60, please check the Laser Configuration settings in the RT Configuration and adjust the Workflow Type according to your actual workflow. Additionally, it is generally recommended that you "perform a quality assurance procedure after any change to the external laser system or any change to the software application" (c.f. IFU chapter 2.6 and 4) to ensure that the laser coordinates are correctly calculated.

It is sufficient to check that the default Workflow Type is correct. There is no technical update needed.
