URGENT Field Safety Notice

Allura Xper, Allura Centron, and Azurion systems
Potential loss of imaging functionality resulting from no or intermittent X-ray radiation initiation through the wired foot switch.

15-August-2023

Reference: 2023-IGT-BST-004: Allura Xper, Allura Centron, and Azurion Systems.

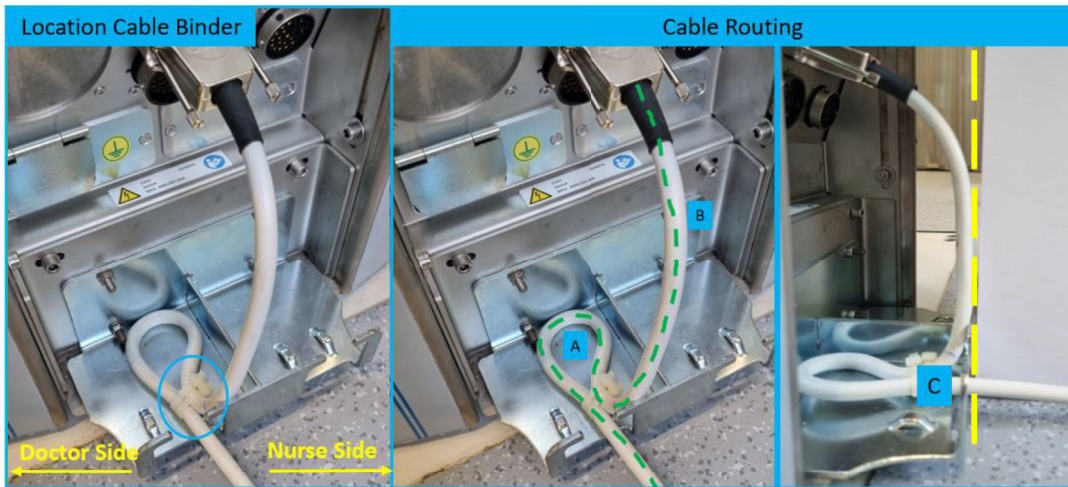
Figure 1: AD7XT and AD7XNT Patient Table

Number of cable binder(s): 2 (two)

If strain relief or routing is not correct, repair according to the repair instructions.

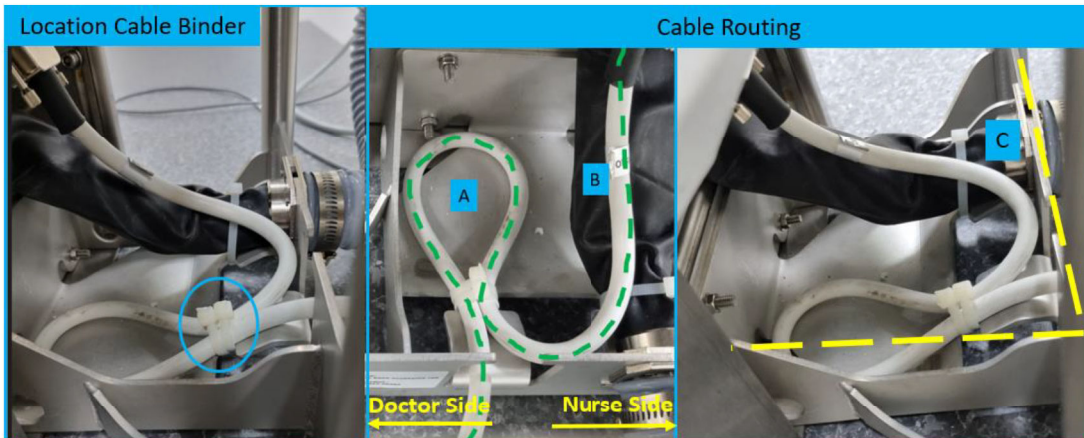
Figure 2: AD7XT and AD7XNT Auxiliary OP Rail Patient Table Strain Relief

Number of cable binder(s): 2 (two)

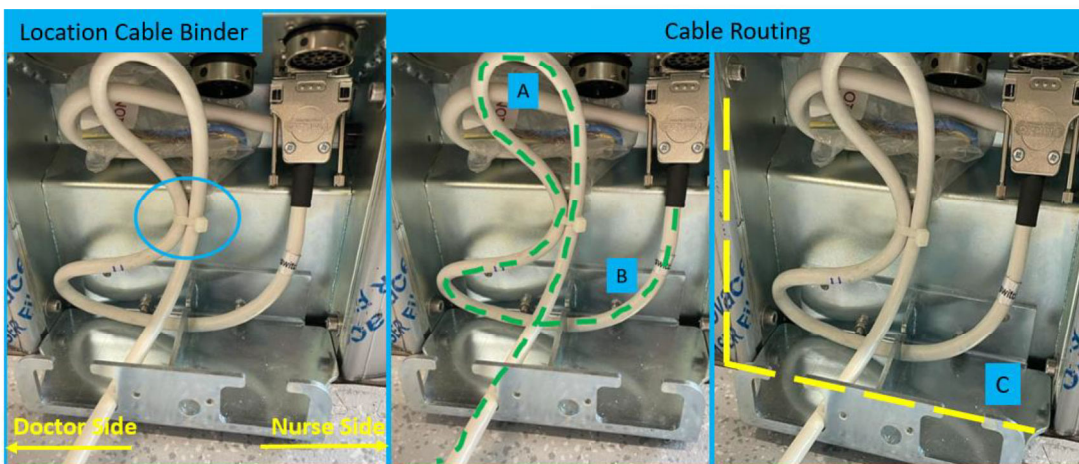
Figure 3: AD7 Patient Table

Number of cable binder(s): 1 (one)

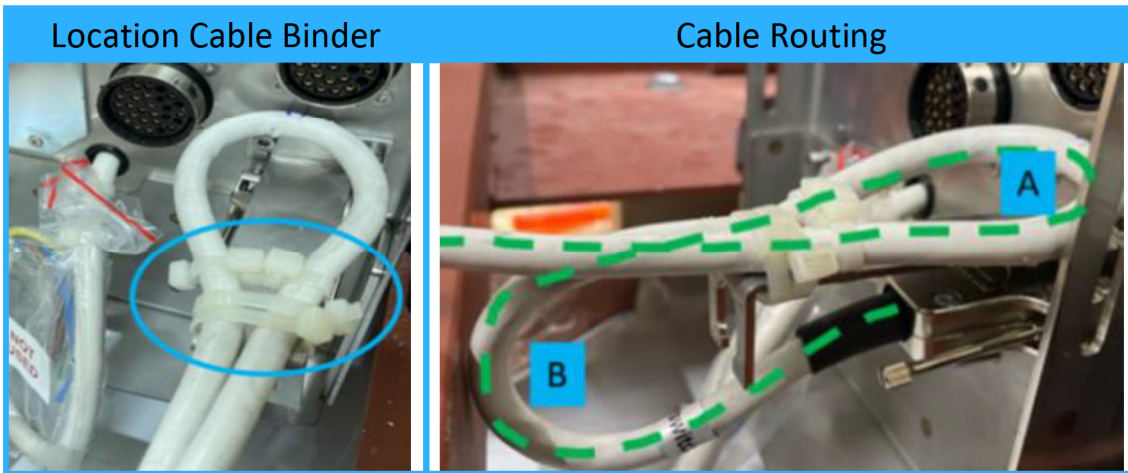
Figure 4b: AD7NT Patient Table with cable tie strain relief

Number of cable binder(s): 5 (five)

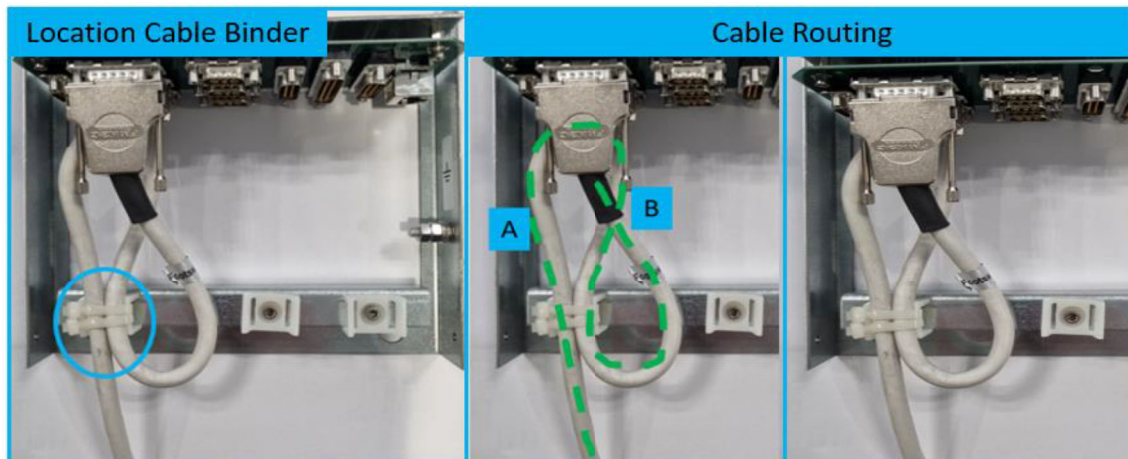
Figure 5: Pedestal Wall Connection Box

Number of cable binder(s): 2 (two)

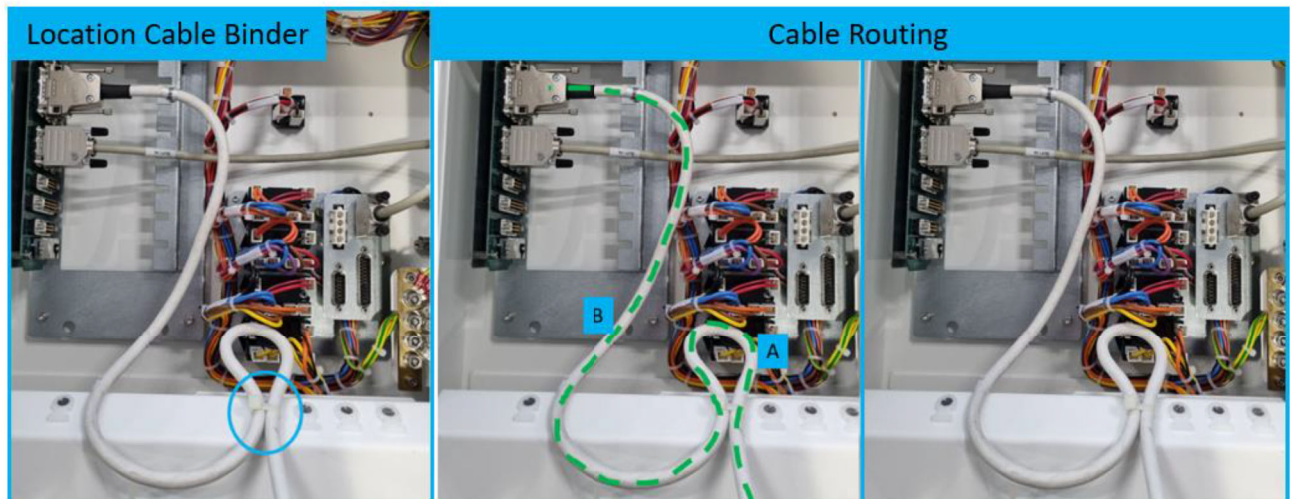
Figure 6: Surgery Wall Connection Box

Number of cable binder(s): 1 (one)

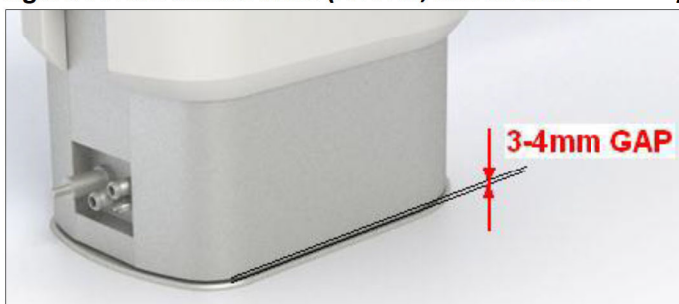
Figure 7: Non-swivel table (AD7NT, AD7XT and AD7XNT)

- For a non-swivel table
 - Make sure that the clearance to the fluid protection plate is 3-4 mm
 - Refer to Figure 7
- For a swivel table
 - Make sure that the clearance to the swivel cover is 3-4 mm
 - Refer to Figure 8

If the gap between the plinth covers and the floor does not satisfy the above requirement, adjust the plinth cover according to the repair instructions.
