To all users of the following systems: Cios VA30

Product/Trade Name:	Cios Spin, Cios Alpha, Cios Flow	EU-SRN	DE-MF-000006122
UDI-DI:	04056869153506, 04056869153490, 04056869246628	E-mail	advancedtherapies-fsca.team@siemens-healthineers.com
		Date	September, 2023
		Corrective Action ID	AX036/23/S

Customer Safety Information (CSI) for Field Safety Corrective Action

Subject: Fulfillment of new requirements from DIN and IEC standards for Cios VA30 Systems

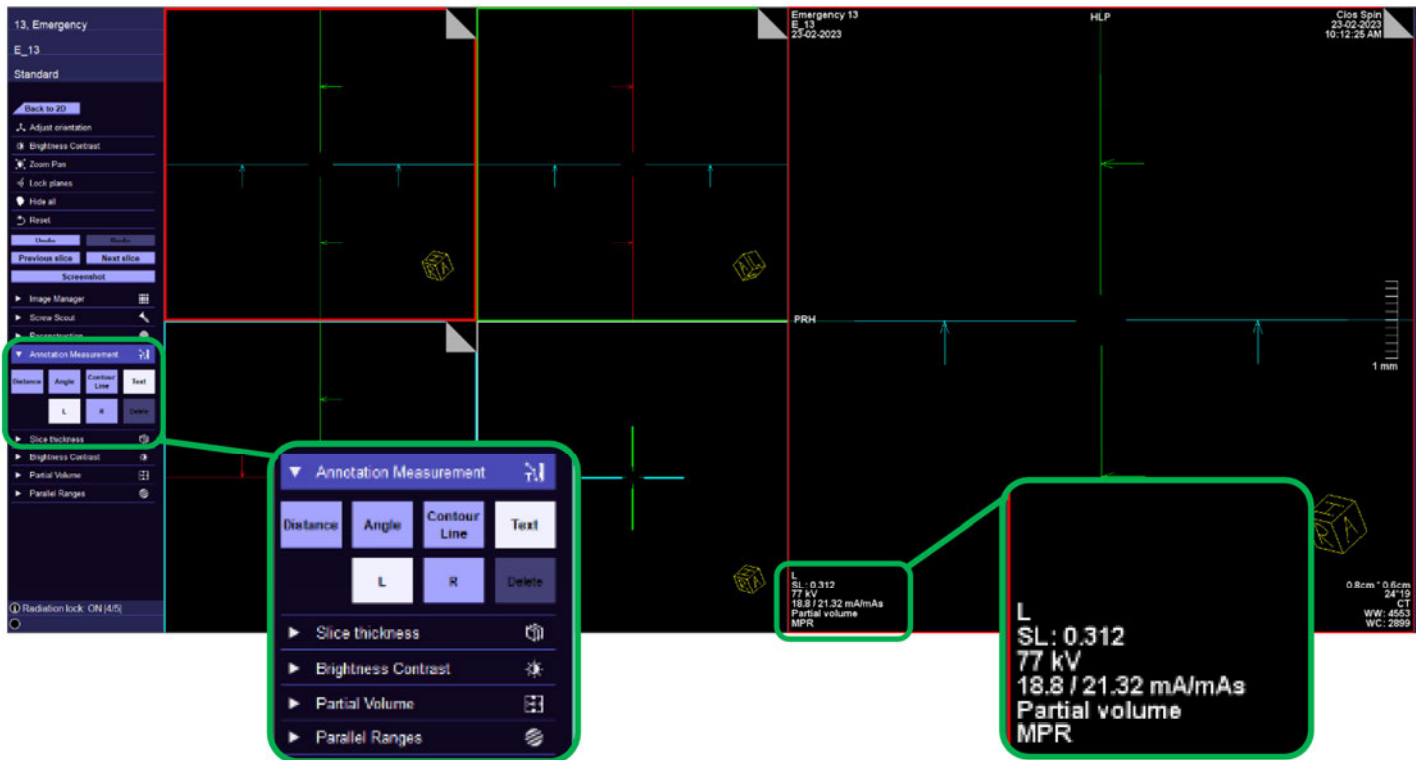
So far, in 3D mode, information about image orientation regarding "laterality" (i.e., L = left / R = right) cannot be defined and saved with the clinical image by the user.

In 3D mode, the user could mix up the patient orientation regarding “laterality”. Therefore, the user could carry out a wrong diagnosis and/or wrong treatment based on the acquired clinical images, which does not show clear information about patient orientation.

In 3D mode and if patient orientation information is important in a procedure, the user can predefine the patient orientation “L/R” (left/right), and therefore “laterality” information will additionally be saved in the clinical image (see screenshot of user interface below).
