URGENT Field Safety Notice

BrightView, BrightView X, BrightView XCT
Patient Extremity Entrapment Hazard while using Pre-Programmed Motion

November 28, 2023

Reference: 2023-PD-CTAMI-011 BrightView Detector Collision (FCO88200537)

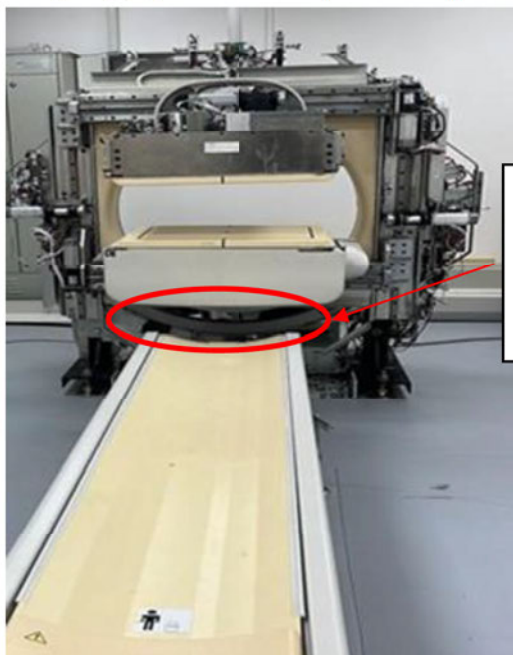
Figure 1. Image of gap between the patient support and detector

While using Pre-Programmed Motion (PPM) during an extrinsic quality assurance scan, a gap is created between the patient support and the detector. This gap presents a potential extremity entrapment hazard for patients while the system detectors and patient support are in motion.

Gap between the detector and patient support. During PPM, the gap may decrease creating the potential for extremity entrapment.

Philips has received one (1) report of an adverse event associated with this issue. In this reported event, the operator positioned a patient on the patient support and initiated the total body Pre-Programmed Motion (PPM). While the patient support and detectors were in motion, the patient straightened their leg due to a cramp, causing their foot to extend and become entrapped between the patient support and the detector. The patient sustained a foot fracture.

- **Monitor the patient during system movement when the Pre-Programmed Motion is in use and review the warning and caution guidance information below, as outlined in *Section 2: Safety and Regulatory Agency Compliance in the Instructions for Use:***

- If the patient extends beyond the end of the imaging table, reposition the patient before starting any preprogrammed motion.
 - Vigilantly watch the patient to make sure that equipment or patient motion does not result in patient harm or equipment damage.

- If you perform a PPM with the patient on the imaging table, monitor the equipment motion closely to avoid contact with the patient object.
 - If any part of the system looks as if it is going to collide with the patient, use an emergency stop button to immediately stop system motion.

Philips will contact you to schedule a time for a Philips Field Service Engineer (FSE) to visit your site and install a technical solution to resolve this issue (refer to FCO88200537).
