URGENT Field Safety Notice

Philips **Azurion System** R1.0, R1.1, R1.2, R2.0, R2.1, and R2.2
Potential loss of imaging functionality and clinical data stored in the system

08-DEC-2023

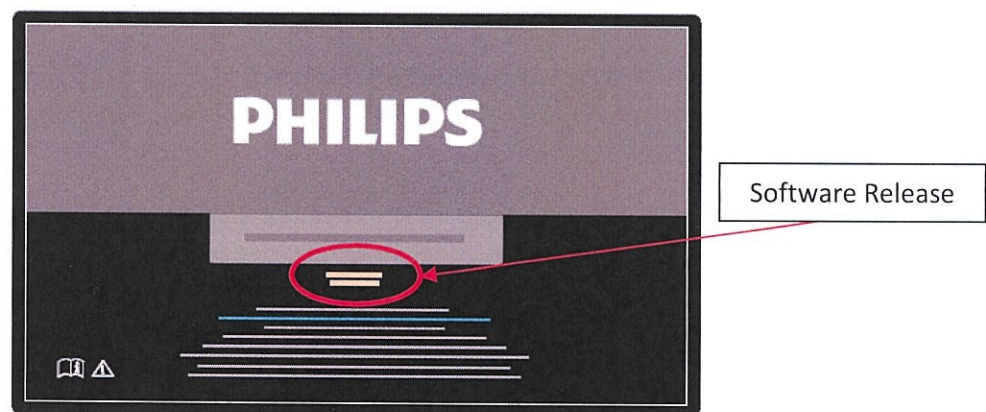
Figure 2: System start-up screen

The software version of the Philips Azurion system can be identified during start-up (Figure2).

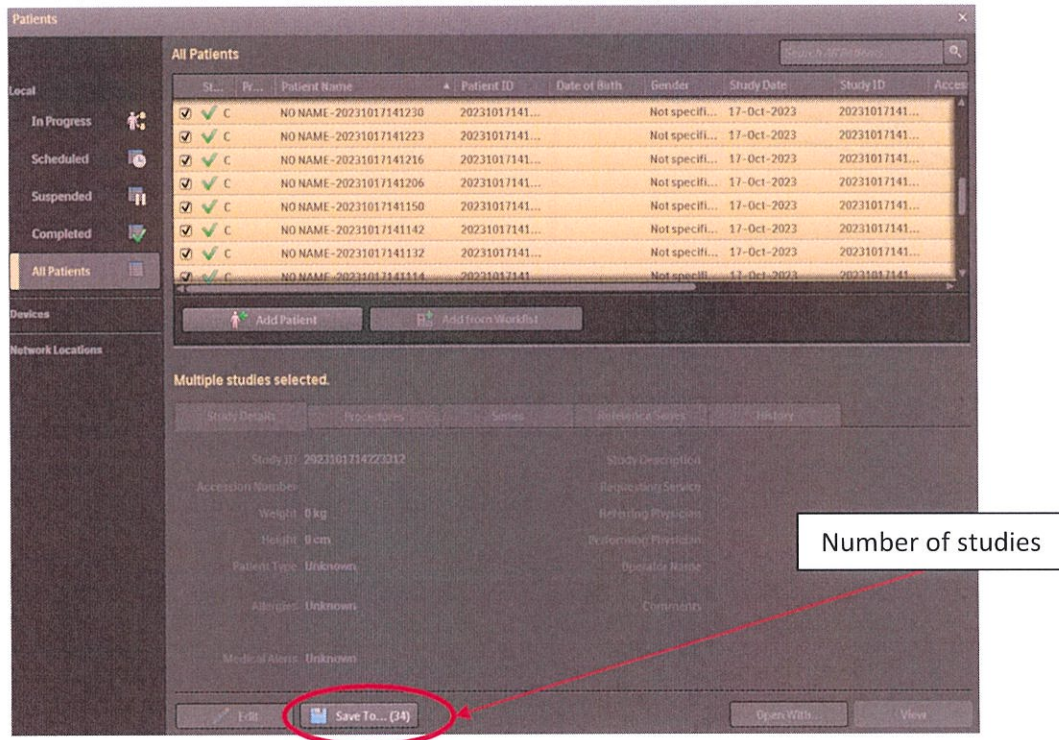
The number of studies can be determined by selecting all studies in the table (Ctrl+A). The number of studies is displayed at the lower part of the screen, see image below.

Note: There is no direct relation to the image disk space used. The number of studies can be high while the image disk is only partially filled, in case only a few images are saved for each patient.

- When deleting studies, ensure the studies are archived and delete the studies in small batches (<10).
- Circulate this notice to all users of the system so that they are aware of the issue.
- Return the attached response form (page 5) to Philips promptly and no later than 30 days from receipt to confirm that the users of the system have reviewed and understood this Field Safety Notice and required actions to be taken.
