**URGENT Field Safety Notice**

Azurion 7 M20 FlexArm system with Maquet Magnus Table  
 Unavailable Motorized Table and/or FlexArm Movement Potentially Resulting in Delay or Termination  
 of Procedure.

08-DEC-2023

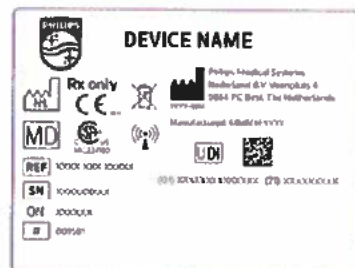
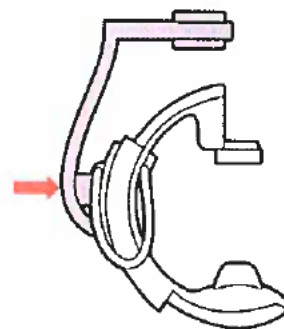
The Device Name, Product Code, Serial Number, and UDI can be found on the System Identification Label located on the FlexArm stand:
