**URGENT Field Safety Notice**

Azurion 7 M20 FlexArm system with Maquet Magnus Table  
Unavailable Motorized Table and/or FlexArm Movement Potentially Resulting in Delay or Termination  
of Procedure.

08-DEC-2023

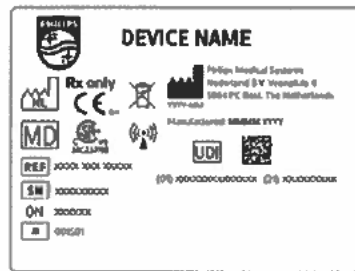
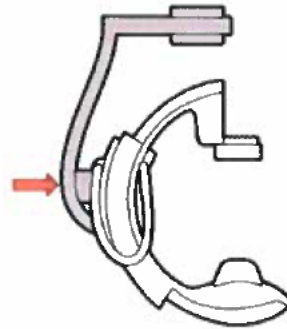
The Device Name, Product Code, Serial Number, and UDI can be found on the System Identification Label located on the FlexArm stand:

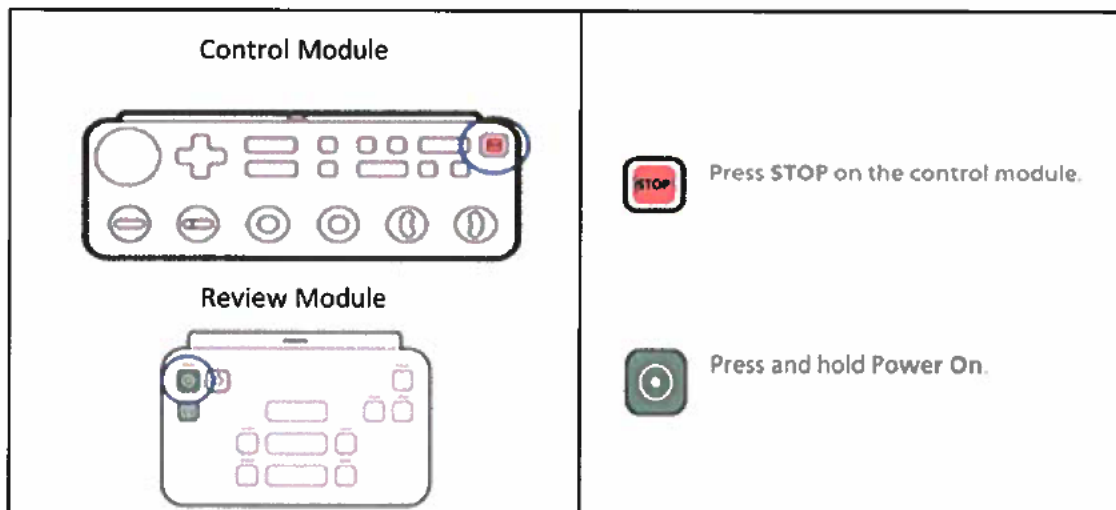
- Until Philips implements the solution in your system. during the procedure:
  - a) Avoid positioning the detector at approximately four (4) cm from the patient.
  - b) If the Connection Issue occurs, perform the following actions in **sequential order**:
    1. move the detector so that it is no longer at approximately four (4) cm from the patient.
    2. if moving the detector doesn't resolve the issue, restart the geometry of the FlexArm as follows:
      - o Press 'STOP' on the **Control Module**
      - o Press and hold the 'Power On' button on the **Review Module**

After this, both Table movement and FlexArm motorized movement will become available again.
