**URGENT Field Safety Notice**  
**ProxiDiagnost N90 1.1 and ProxiDiagnost Upgrade**

Software Defects causing imaging issues during Radiography and Fluoroscopy examination

05-December-2023

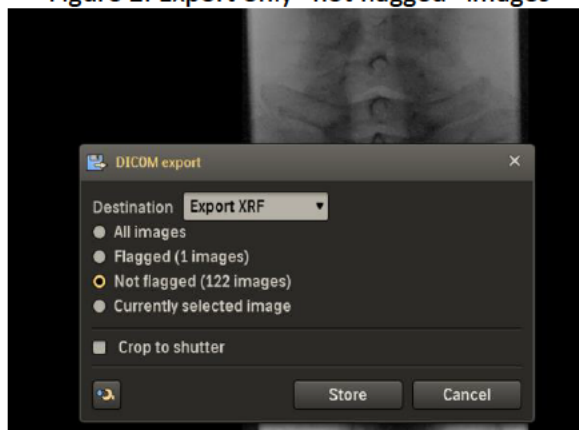
**Figure 2. Export only “not flagged” images**

**Issue 1: Mixed Images:** Philips has identified that the Radio Fluoroscopy (RF) viewer may also display a previous patient's radiography (RAD) images when starting the next patient scan while the previous patient image export is still processing. If the issue occurs, there is a potential for incorrect patient data to be displayed in the image.

- To avoid previous patient data from being represented as current patient data, ensure all images have been exported from the previous RAD exam before starting a new examination.
- Correct images will be square shape and wrong images can be recognized by a different patient anatomy and rectangular shape. If you identify a wrong image, flag the incorrect images and only export “not flagged” images for the current examination to PACS (See figure 2 below).
