URGENT Field Safety Notice

BrightView, BrightView X, BrightView XCT (Product Codes 882480, 882478, 882482)
Potential Detector Fall could Result in Injury to the Patient

December 14, 2023

Reference: BrightView, BrightView X, BrightView XCT Potential Detector Fall could Result in Injury to the Patient, 2023-PD-CTAMI-019 (FCO88200538)

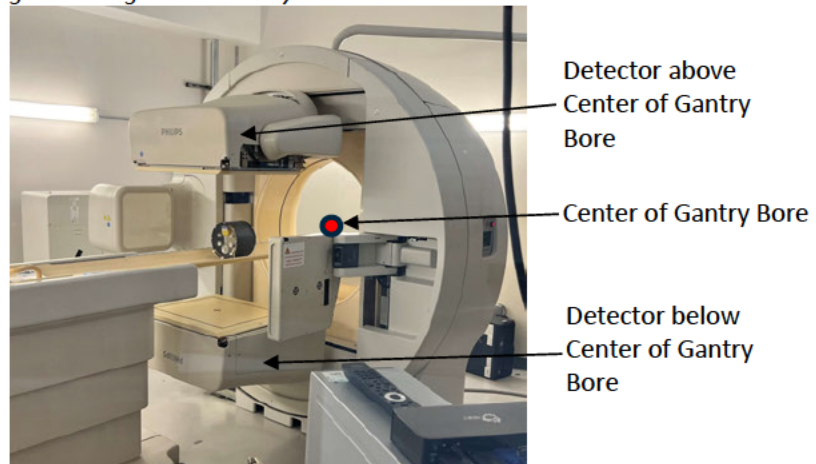
Figure 1. BrightView XCT system detector location

- **Scenario 1:** If the detector is below the center of the gantry bore and the detector support component fails, the detector may descend downward unexpectedly and potentially contact the patient.
- **Scenario 2:** If the detector is above the center of the gantry bore and the detector support component fails, the detector will not be able to move to complete the imaging.

Refer to Figure 1 for the location of detectors relative to the gantry bore.

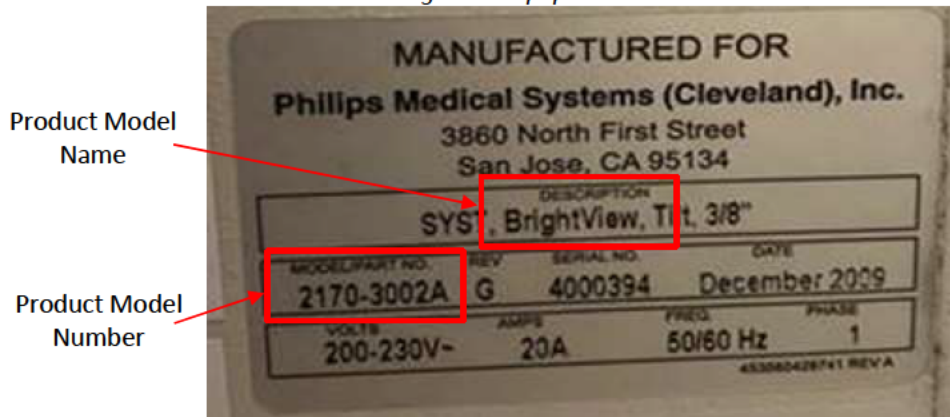
Figure 2. Equipment label

To locate the product model name and product model number, locate the equipment label on the back of the gantry near the bottom right as shown in Figure 2. Figure 2 shows a sample label for BrightView product model 2170-3002A (882480) as an example. Note: The system label may not have the same digit format as the example shown below.

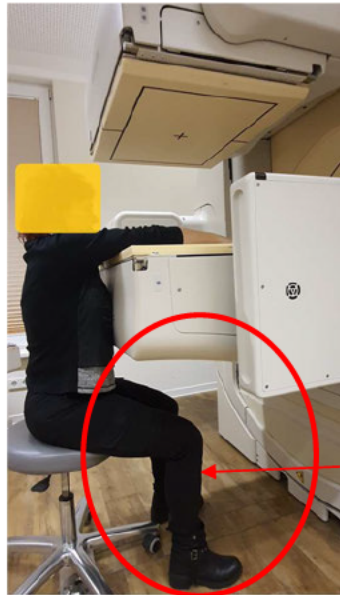
Figure 3. Avoid positioning a patient's lower limbs under the detector below Center of Gantry

Scenario 1, Detector positioned below center of gantry: If the patient’s lower limb(s) is directly below the lower detector and the support component fails, the detector may descend downward in an uncontrolled manner and contact the patient. There is a potential for abrasion, contusion, laceration, and/or fracture to the patient’s lower limb(s). Additionally, there will be an interruption to normal system operation. A rescan or re-injection of radiopharmaceutical to the patient may be required.

- **Do Not** position a patient's lower limbs directly under the detector below the Center of Gantry bore (refer to Figure 3), for example while performing dual head (DH) hand (left/right) procedure.

Do not position a patient's lower limbs under the lower detector

Philips will contact you to schedule a time for a Philips Field Service Engineer (FSE) to visit your site and to inspect and correct the system if necessary (FCO 88200538).
