Field Safety Notice, Medical Device Correction #15483

RayStation 4.5, RayStation 4.7, RayStation 5 and RayStation 6

January 18, 2017
RSL-D-61-319

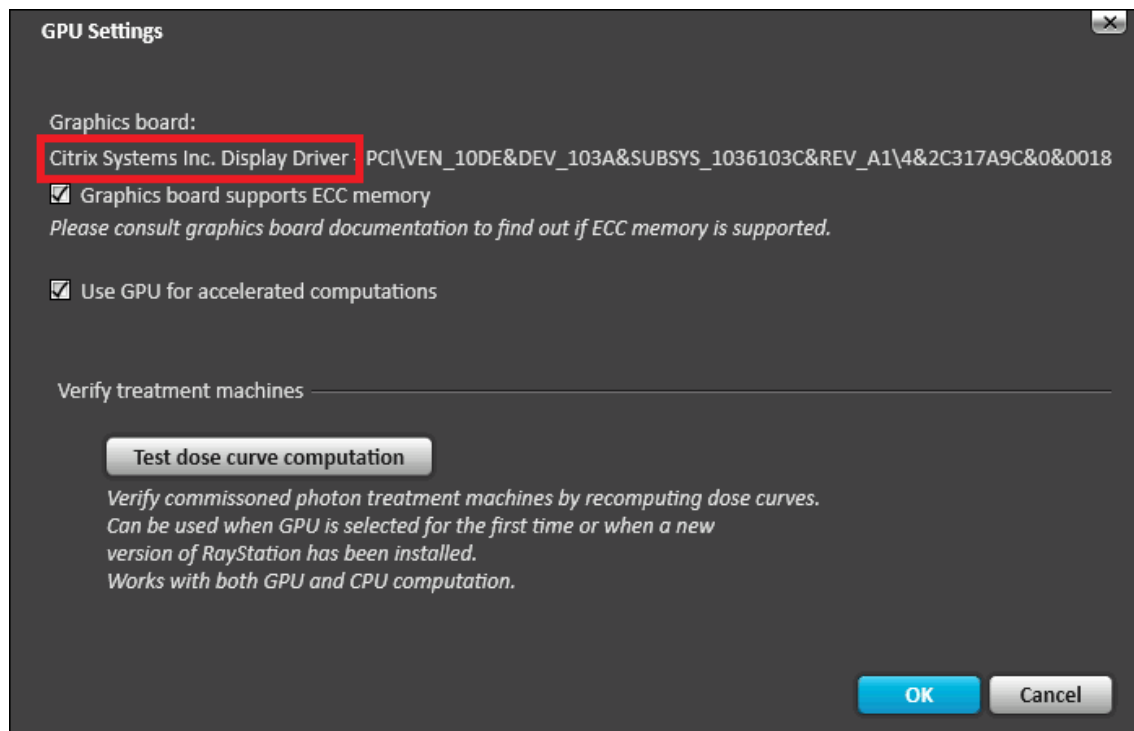
Due to a known error in NVIDIA GPU card drivers, RaySearch has prevented GPU based computations for very large computation problems. However, in an incorrect Citrix XenApp configuration, the GPU may not be correctly identified and the erroneous calculation may be allowed.

If this occurs, accelerated computation on GPU may give incorrect results for very large computation problems. Dose computation will be affected if the dose grid contains more than 134217728 voxels for a photon plan or more than 67108864 voxels for a carbon ion plan. The main effect on calculated dose is that it may be incorrectly set to zero in parts of the dose grid. Normally this would be highly detectable. There may also be some smaller impact on the dose in the non-zero region e.g., due to missing in-scatter when TERMA computation has been affected by the error.

In an incorrect installation of Citrix XenApp, the NVIDIA GPU may be displayed as "Citrix Systems Inc. Display Driver":

An incorrect installation can be detected by opening the GPU settings in RayStation and viewing the current configuration, see ACTIONS TO BE TAKEN BY THE USER for instructions.

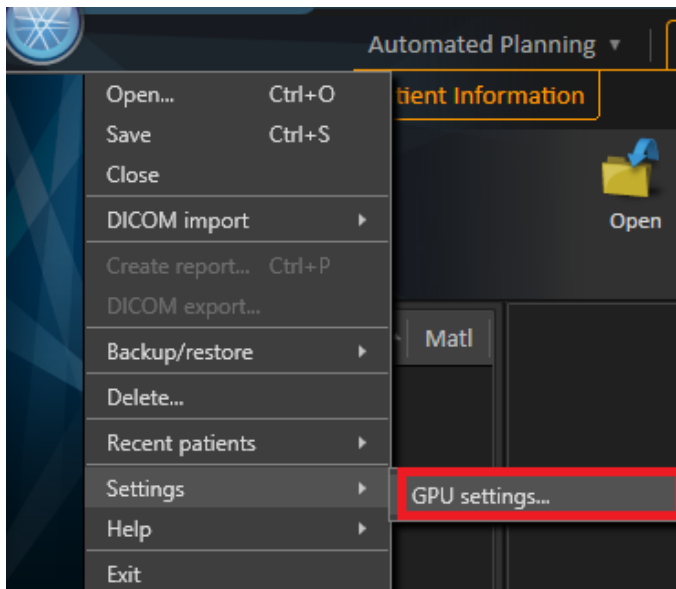
1. Click the RayStation icon in the upper left corner of the view in the application and select **Settings: GPU settings....** This will open the **GPU settings** dialog.

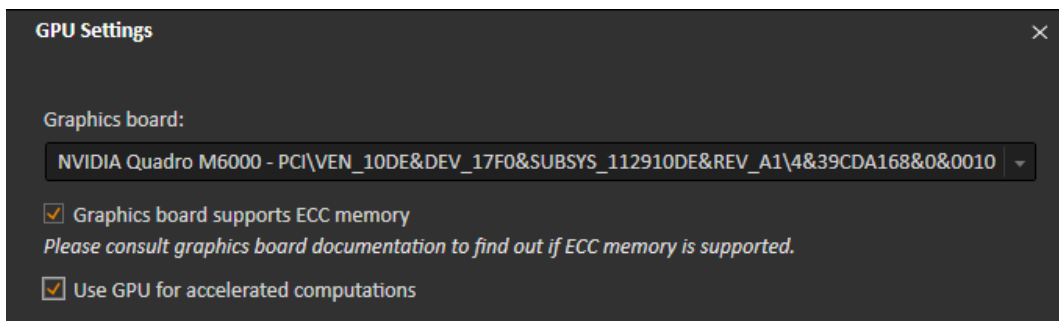
2. Check that displayed graphics board in the **GPU Settings** dialog is listed as verified for operation according to the section "Graphics card (GPU) for accelerated computations" in the System Environment Guidelines. The following figure shows an example of a correct installation:

If the graphics board is not verified for operation according to the System Environment Guidelines, the installation is incorrect. In this case, disable GPU computation and contact RaySearch Support.

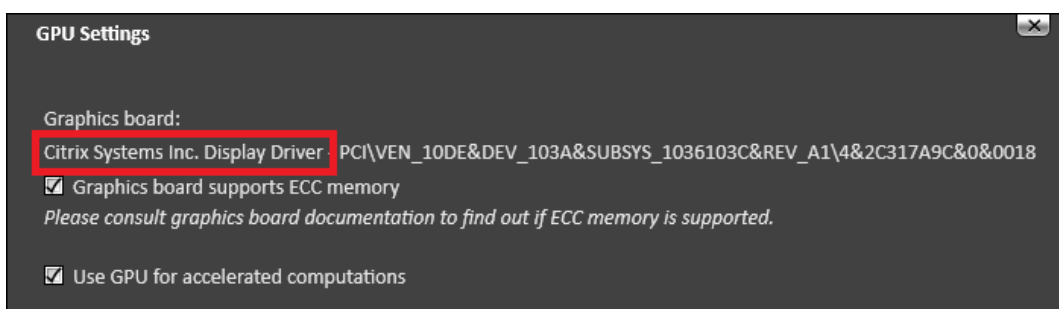
3. Check if "Citrix Systems Inc. Display Driver" is displayed instead of the graphics board name. If so, the Citrix XenApp installation is incorrect.

If an incorrect installation of Citrix XenApp is detected:

- a. Set the Citrix XenApp server to maintenance mode or disable GPU computation on the erroneous server.
- b. Contact RaySearch Support for instructions on how to resolve the issue.
