URGENT FIELD SAFETY NOTICE

Regarding **ProteusPLUS** and **ProteusONE**

MID-59393 REV. A

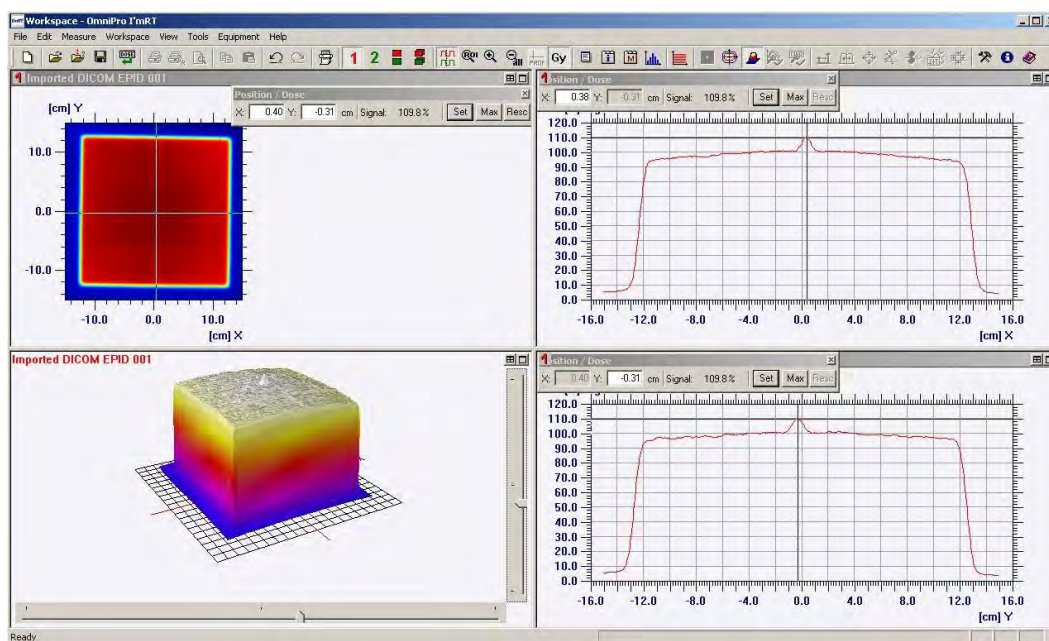
- Run the “Dark Beam” QA Map² with the LYNX dosimetry tool at maximum energy,
- If there is a peak in the center of the beam profile as shown on Figure 1:
 - o Confirm it is due to dark current by running the same QA Map at the lowest energy (if there is no peak, it is most probably due to dark current),
 - o Contact IBA to analyze and fix the issue.

Figure 1 - Peak in the center of a beam profile due to dark current. Here the pick value is 110% of the dose but it could be a higher or lower value depending on the intensity of the dark current.

In case a peak is observed on the beam profile, it is suggested to open a downtime event until the dark current issue is fixed.

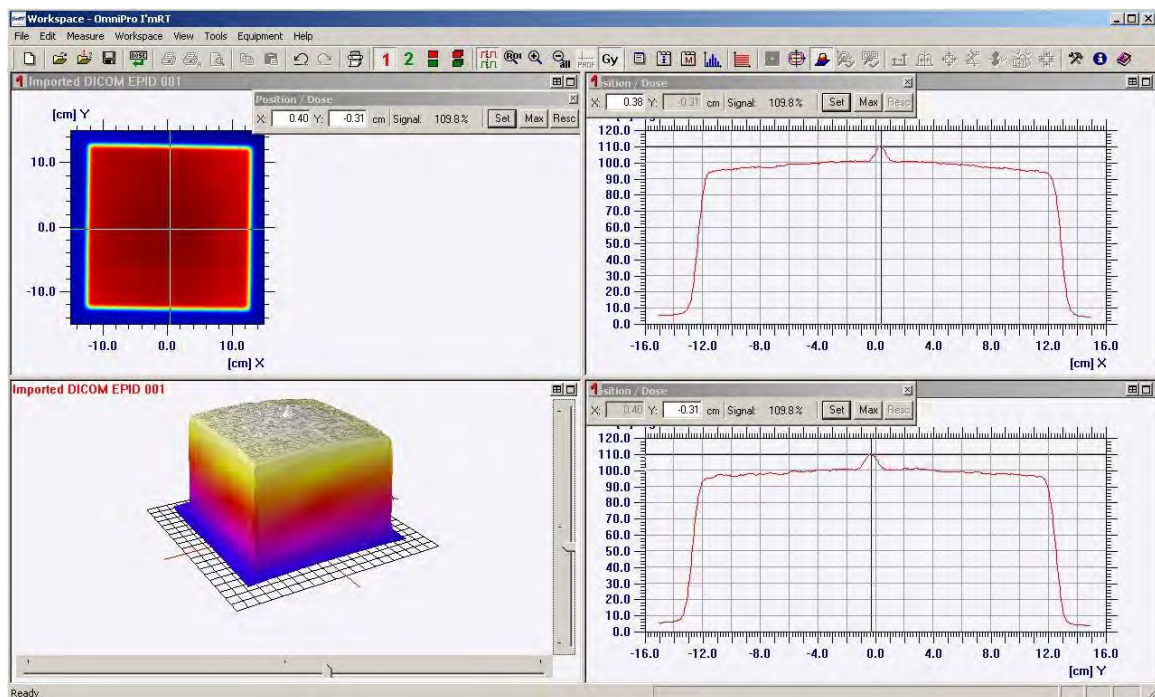
- Run the “Dark Beam” QA Map with the LYNX dosimetry tool at maximum energy,
- If there is a peak in the center of the beam profile as shown on Figure 1:
 - o Confirm it is due to dark current by running the same QA Map at the lowest energy (if there is no peak, it is most probably due to dark current),
 - o Contact IBA to analyze and fix the issue.

Figure 1 - Peak in the center of a beam profile due to dark current. Here the pick value is 110% of the dose but it could be a higher or lower value depending on the intensity of the dark current.

In case a peak is observed on the beam profile, it is suggested to open a downtime event until the dark current issue is fixed.
