URGENT FIELD SAFETY NOTICE / PRODUCT NOTIFICATION

Subject: ExacTrac Dynamic - Patient Positioning System:
For CBCT positioning workflows using setup beams with Varian LINACS, yaw angle may be incorrect

Product Reference: ExacTrac Dynamic 1.0.0, 1.0.1, 1.0.2, 1.0.3

Date of Notification: February 07, 2022

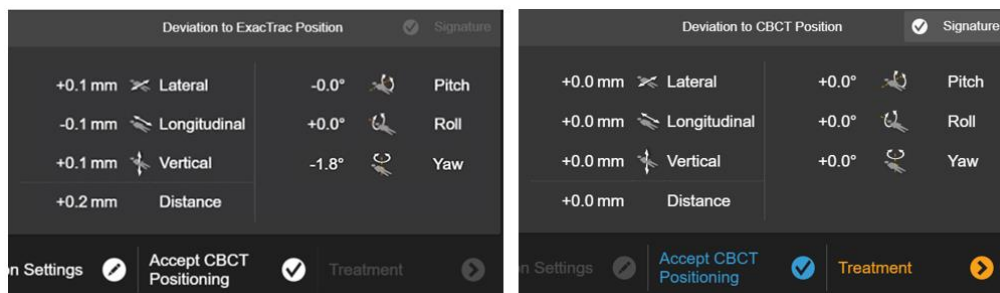
More specifically, it is calculated from the values displayed in the ETD software as shown in Figure 2a “Deviation to ExacTrac Position”, by inverting the signs. After the user selects “Accept CBCT Positioning”, the CBCT offset is added, such that the final ETD position results in 0mm/0° in all dimensions, indicating that from now on the CBCT position is accepted as the reference position (shown in Figure 2b).

Figure 2a (left): The deviation between the current patient position and the planned ExacTrac internal position. **Figure 2b (right):** The CBCT offset has been added to the ExacTrac internal position, resulting in 0mm/0° in all dimensions.

Once the user selects “Accept CBCT Positioning”, the displayed yaw value changes to 0 as displayed in Figure 2b. Thus the wrong ETD internal position and wrong CBCT offset initially compensate each other and lead to expected 0 result in all directions.
