FSN Ref: IBA PR-122324

Amended Urgent Field Safety Notice

Regarding **IBA Proton Therapy System - Proteus 235**

Layers of Uniform Scanning treatment fields may be delivered with incorrect Scanning Magnet setpoints

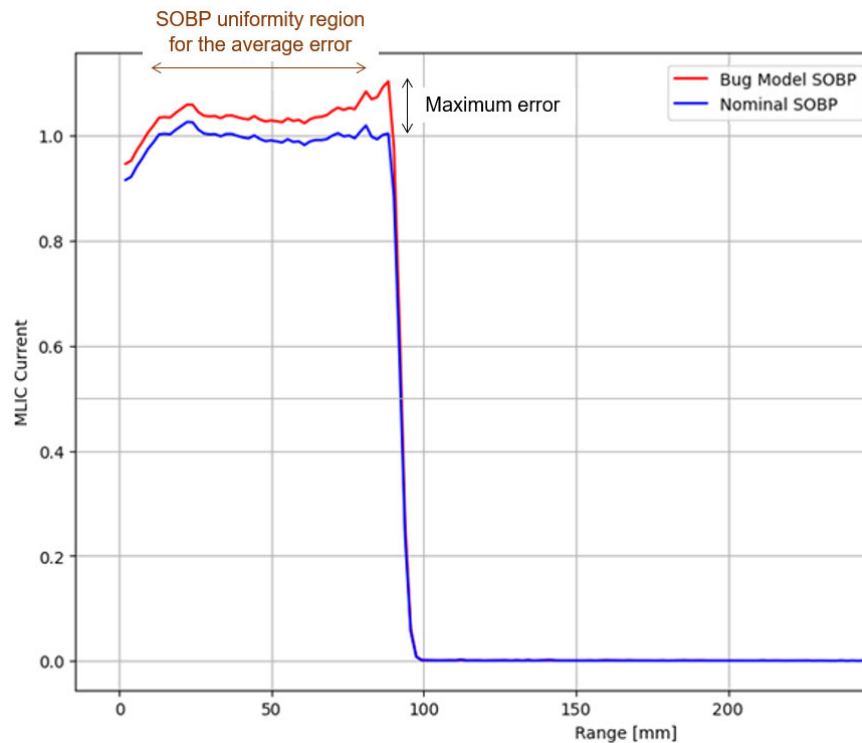
IBA has computed the maximum and average dose errors (see Figure 1) based on IBA uniformity model :

- the maximum dose error is the maximum difference between the nominal Spread-Out Bragg Peak (SOBP) and the SOBP affected by the issue. For the 494 fields identified, the maximum error varies between 0 and 22,5%.

- the average dose error is the dose error computed over the SOBP uniformity region, defined as the region between the proximal 98% and two distal fall-off widths from the distal 50%. For the 494 fields identified, the average error varies between 0 and 12%.

Figure 1: Maximum dose error and uniformity region for the computation of the average dose error

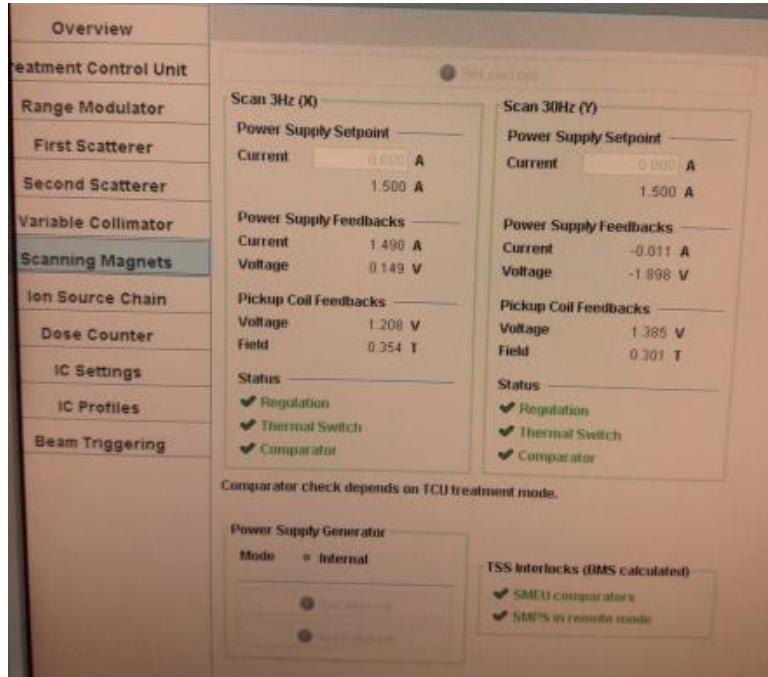
Figure 3: Nozzle service screens – Scanning Magnets

<p>TYPE OF ACTION TO MITIGATE THE RISK</p>	
<p>ACTION TO BE TAKEN BY THE USER</p>	<p>Waiting for the solution to be provided, wait at least 10 seconds between the manual reset of the Dosimetry Counter Electronic Unit (DCEU) and the request from the therapist to start the irradiation. This delay will prevent from delivering the first layer with the Scanning Magnets still set at the tuning setpoints.</p> <p>In addition, if a beam pause is generated during the first layer despite the delay between the reset of the DCEU and the start of the irradiation, call IBA operator to check the Scanning Magnets in the nozzle service screen (see Figure 3). If the "Pickup Coil Feedbacks" are still set to 1.5V (+/-0.2V) from the tuning, abort the field and re-load it for another attempt (since the</p>

problem happens infrequently, the chances are high that the partial irradiation will be able to proceed as expected).
