## SAFETY INFORMATION

## Limited mandatory field action PV 403 PEEP

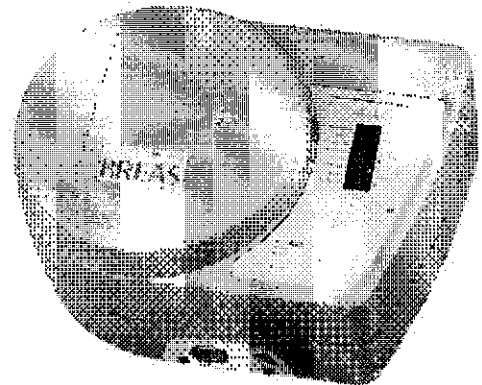
CPU boards equipped with components from this batch were produced during 2006.

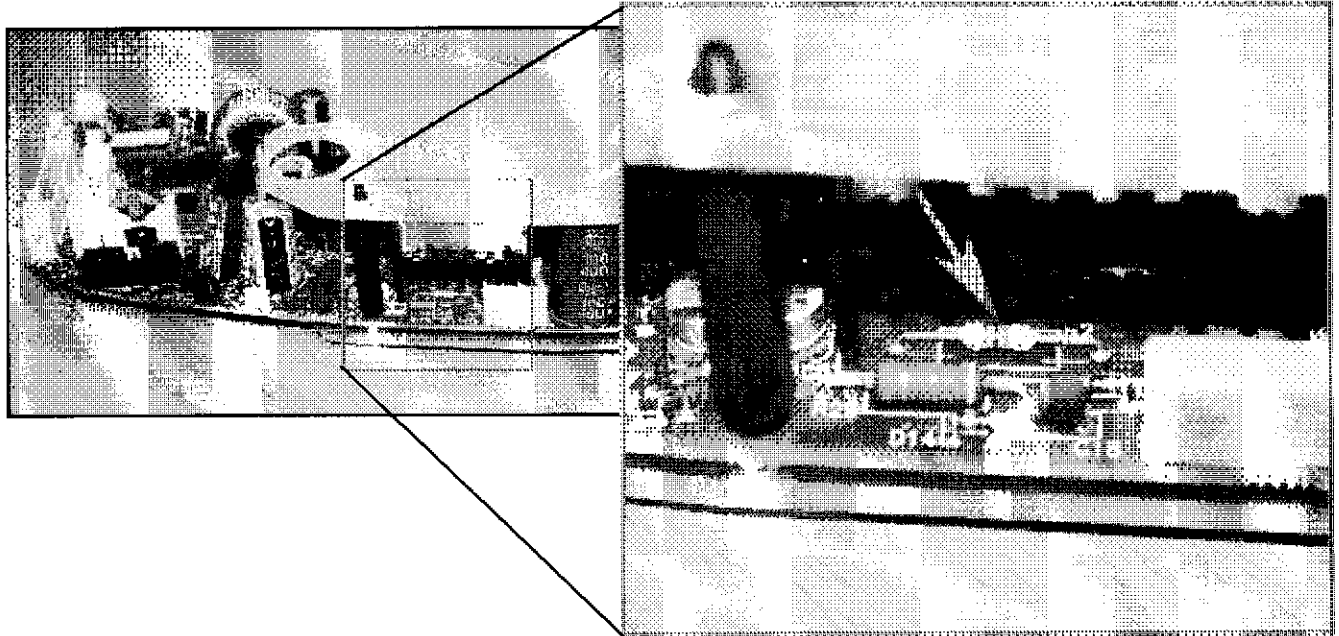
**Action alternatives:**
