# Urgent Medical Device Correction Notification

## EXCOR® Cannulae

Date: 2023-08-08

**Sender:** Berlin Heart GmbH

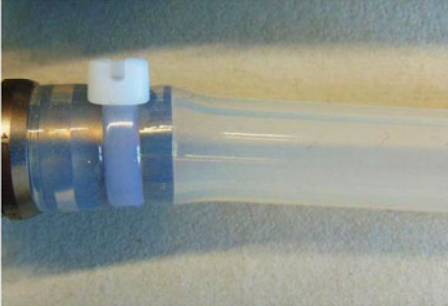
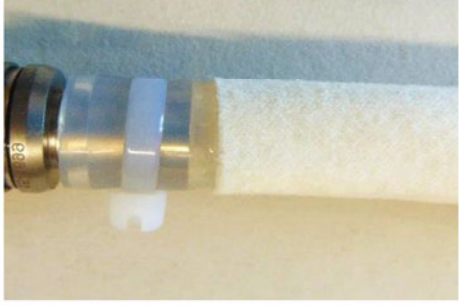
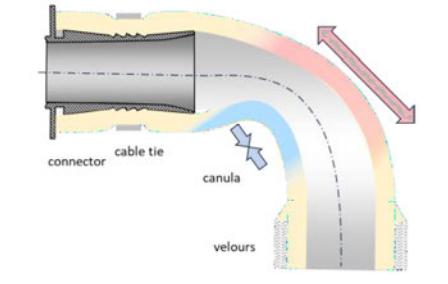
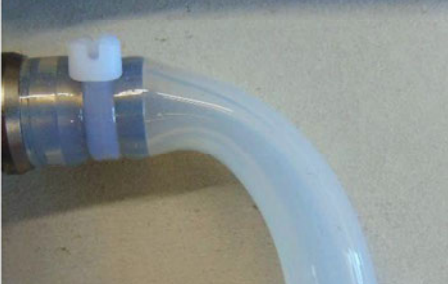
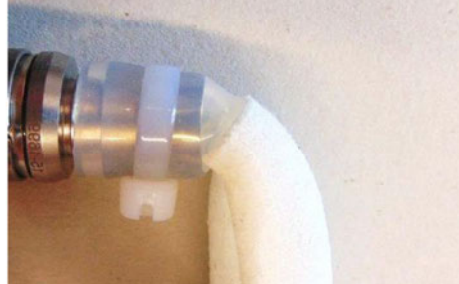
## 2. Distance between the connector and the velour of the cannula

If the distance between the connector and the velour of the cannula is too small, this may restrict the free movement of the cannula and cause damage to the material due to the force exerted during kinking.

<p style="text-align: center;"><b>Correct Length</b> (Minimum length of 5 cm)</p>	<p style="text-align: center;"><b>Incorrect Length</b> (Velour connected within less than 5 cm)</p>

<p><b>straight position</b></p>

<p><b>kinked position</b></p>

3. At least 5 cm (2 inches) of the cannula without the polyester velour covering must remain to avoid damage to the cannula stubs and to allow for visual inspection of the cannula/titanium-connector junctions.

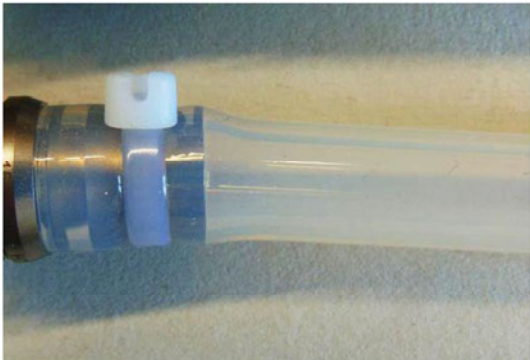
Correct Position of Cable Tie	Incorrect Position of Cable Tie

A photograph showing a white cable tie wrapped around a clear plastic tube. The tie is positioned over a metal fitting on the tube, ensuring it is secure and does not obstruct the flow path.

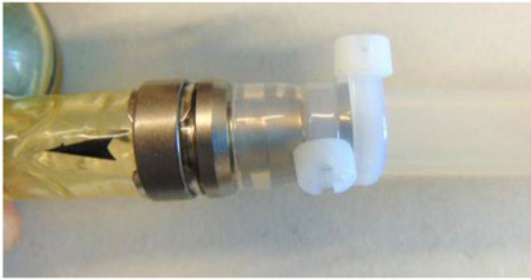
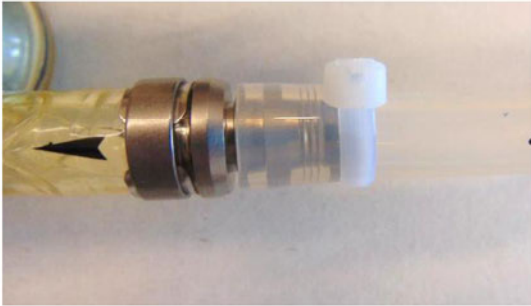
Two photographs showing incorrect cable tie placement. The top image shows a white cable tie wrapped around a clear plastic tube, but it is positioned under a metal fitting, which could obstruct the flow path. The bottom image shows a white cable tie wrapped around a clear plastic tube, but it is positioned over a metal fitting, which could obstruct the flow path.
