URGENT - Medical Device Correction

Pneumograph, Chest, NM, 3160

Device Labeling Does Not Include Statement Regarding Natural Rubber Latex Content

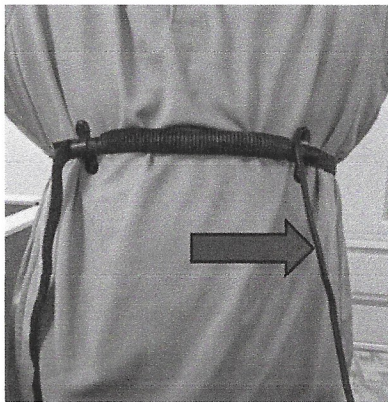
AFFECTED PRODUCTS	<table border="1" data-bbox="412 552 1003 617"> <thead> <tr> <th>Part Number</th><th>Part Description</th></tr> </thead> <tbody> <tr> <td>94023</td><td>Pneumograph, chest, NM, 3160</td></tr> </tbody> </table> <p>All chest pneumographs currently in distribution are affected.</p>	Part Number	Part Description	94023	Pneumograph, chest, NM, 3160
Part Number	Part Description				
94023	Pneumograph, chest, NM, 3160				
PROBLEM DESCRIPTION	<p>The chest pneumograph contains 90-95% natural rubber latex in the tubing that extends from the bellows to the wireless oxygen saturation/pulse oximetry (SpO2) module or gating unit (refer to red arrow in the picture to the right). The chest pneumograph is not labeled as containing natural rubber latex.</p>

ACTION TO BE TAKEN BY CUSTOMER / USER	<p>Please review this communication with all members of your staff who utilize this product. Please retain a copy with the equipment Instructions for Use.</p> <p>The chest pneumograph can continue to be used for monitoring as directed by a physician.</p> <ol style="list-style-type: none">1. Identify all affected chest pneumographs in your facility using the guidelines provided in the HOW TO IDENTIFY AFFECTED PRODUCTS section above.<ul style="list-style-type: none">• <i>Please do not return any product to Philips.</i>2. Complete and sign the reply form provided on the last page of this letter.3. Send the completed and signed reply form to Philips via the contact information located on the form.4. Upon receipt of the reply form, Philips will send you one kit per chest pneumograph in your possession along with instructions for labeling each chest pneumograph.5. Upon receipt of the kit, follow the included instructions to label each chest pneumograph in your possession. The label to be added identifies the product as containing latex.

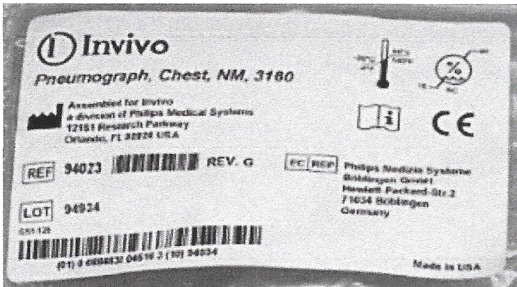
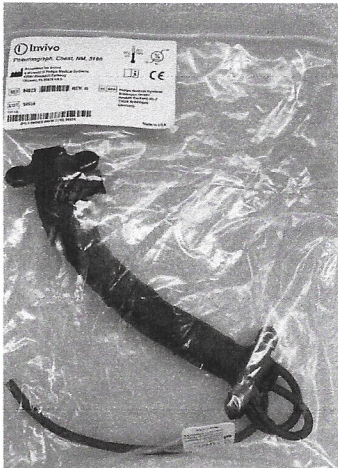
HAZARD INVOLVED	<p>Natural rubber latex is a known allergen that may impact the patient or user due to contact with the device against bare skin. The chest pneumograph is expected to be used over a gown or clothing but there is the possibility of the natural rubber latex tubing contacting the patient's bare arm/leg, patient's bare torso (if no clothing is present), or the user's hands/arms during patient preparation. Allergen related issues could range from minor (irritation or rash) to major (anaphylactic shock).</p>				
HOW TO IDENTIFY AFFECTED PRODUCTS	<p>The pictures to the right and below show the chest pneumograph part as packaged, as well as the label located on the outer packaging.</p>

ACTIONS PLANNED BY PHILIPS	<p>Upon receipt of the completed and signed reply form, Philips will provide one kit per chest pneumograph in each customer's possession for the purposes of labeling each affected chest pneumograph. This kit will be provided free of charge.</p>
FURTHER INFORMATION AND SUPPORT	<p>If you need any further information or support concerning this problem, please contact your local Philips representative: <Philips representative contact details to be completed by the KM / country>.</p>
