March 10, 2017

**Subject:** **URGENT MEDICAL DEVICE REMOVAL – LOT SPECIFIC**

**Affected Product:** iASSIST Validation Tool

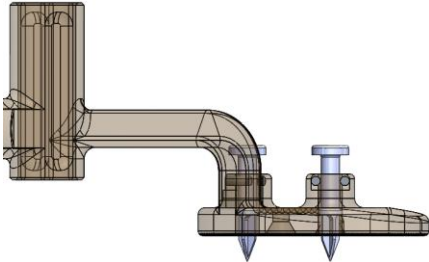
<p>Validation tool 20-8011-021-00 Rev R</p> <p><b>Not affected by the field action</b></p>

As indicated in the pictures above, drawing revision M to P of the Drive Pins has an X cross section instead of circular. Also, the Drive Pin head has a recess in the enlarged head. Only iASSIST Validation Tools with drawing revision M to P Drive Pins, in the red box above, are affected by this field removal.

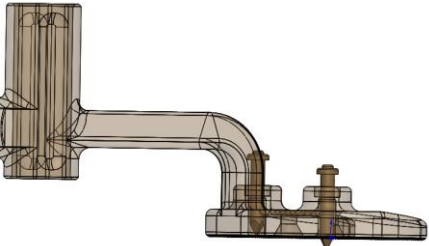
<p>Validation tool 20-8011-021-00 Rev L</p> <p><b>Not affected by the field action</b></p>

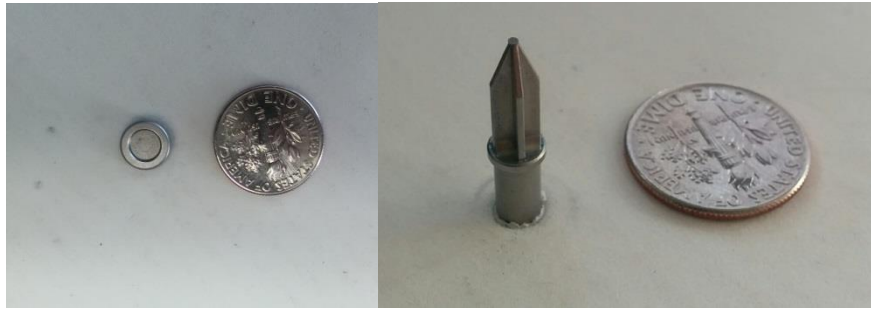
3. Inspect affected devices before and immediately after use to confirm that the Drive Pins are not bent or broken. In case of breakage, the Drive Pin head will disassemble, as shown below. In the unlikely case of a breakage, make sure that both parts are retrieved from the wound.

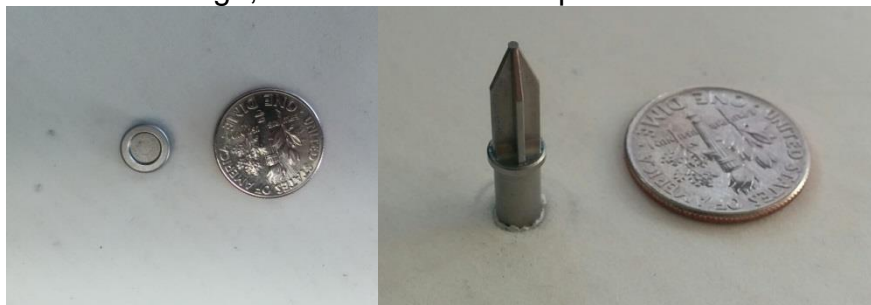
4. Inspect affected devices before and immediately after use to confirm that the Drive Pins are not bent or broken. In case of breakage, the Drive Pin head will disassemble, as shown below. In the unlikely case of a breakage, make sure that both parts are retrieved from the wound.
