Urgent Field Safety Notice**November 25, 2008****Dimension[®] Clinical Chemistry System****HM Reaction Vessels (RXV1A) Physical Defect**

HM Reaction Vessels (RXV1A) Physical Defect

Attachment

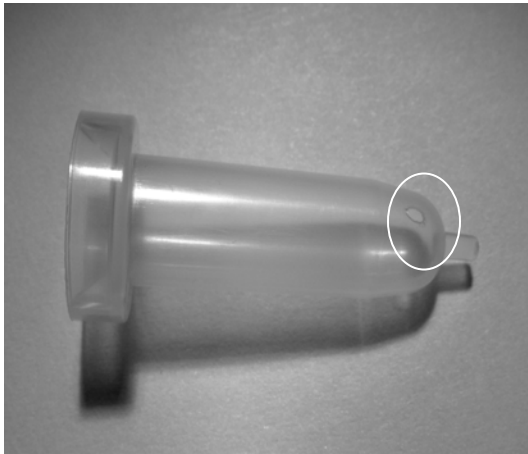
Our records indicate that your laboratory uses HM Reaction Vessels (RXV1A) on the Dimension[®] clinical chemistry system. Siemens has confirmed a low frequency defect in the molding of the HM Reaction Vessels that may result in a hole in the bottom portion of the vessel (please refer to Figure 1 in the attachment). We have determined that the issue is related to a molding defect affecting a single cavity, 7G, of a multi-cavity mold. There are a total of 10 lots that have the potential to exhibit the defect: NC16-182-08, NC16-189-08, NC16-196-08, NC16-203-08, NC16-210-08, NC16-217-08, NC16-224-08, NC16-231-08, NC16-238-08, and NC16-245-08.

Figure 1: Location of HM Vessel Defect, if present

Use of the defective reactions vessels could result in leakage of the reagent with subsequent test report messages such as Abnormal Assay or Abnormal Reaction for HM methods (i.e., CCRP, CTNI, FERR, FT4, FPSA, HCG, LHCG, LMMB, LPBN, LTNI, MMB, MPO, MYO, PBNP, TPSA, and TSH) and Below Assay Range for ACMIA therapeutic drug monitoring (TDM) methods (i.e., CSA, CSAE, DGNA, DGTX, and TACR). Additionally, while extremely unlikely, it is possible to obtain a falsely depressed TDM result without generating a Below Assay Range test report message. Please review this situation with your laboratory director to determine the need to review previously reported TDM results. Delta checks in the laboratory and trending in the patient's medical record may be useful for evaluating prior patient TDM results.

Please immediately examine your inventory of HM Reaction Vessels to determine if you have any of the affected lots. Using the attached instructions, please examine at least one vessel from each bag of affected product to determine if the vessels were molded in the 7G cavity. If 7G is imprinted on the flange of the vessel, discard the entire bag. In addition, please empty the HM reaction vessel holder and track on all Dimension[®] systems in your laboratory and discard the vessels.

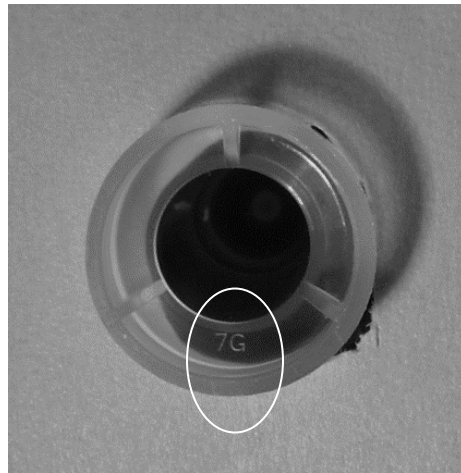
2. Examine at least one vessel from each bag of affected lot you have in inventory to determine if the vessels were molded in the affected cavity, 7G. The cavity marking is located on the inside of the vessel flange, as indicated the Figure 2 below. Discard any bags containing vessels from cavity 7G.

Figure 2: Cavity marking on flange of vessel
