Urgent Field Safety Notice

Affected Products: Magellan Diagnostics Inc. LeadCare II Blood Lead Analyzer (Part numbers 70-6760, 70-6529-R, 70-6760-P, 70-6760-R) AND LeadCare Plus Blood Lead Analyzer (82-0001)

Magellan FSCA Identifier : MHRA20180612

Type of action: FIELD SAFETY NOTICE

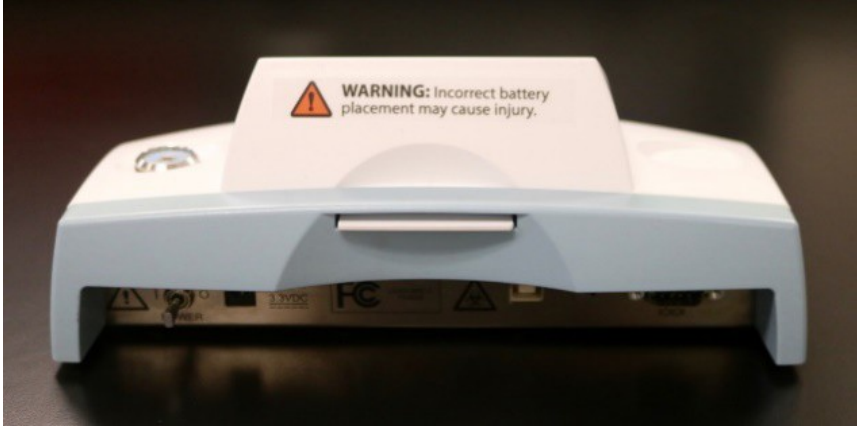
A photograph of the back of a white and light blue LeadCare II Blood Lead Analyzer. A white warning label is affixed to the upper back panel. The label features a yellow triangle with a black exclamation mark and the text: "WARNING: Incorrect battery placement may cause injury." Below the analyzer, the back panel shows various regulatory markings including a triangle with a lightning bolt, a recycling symbol, "3.3VDC", "FC", and a triangle with a lightning bolt.</div> <p style="text-align: center;">LeadCare® II</p> <div data-bbox="403 1384 1264 1809">

3).	<p>Take the battery warning label which accompanies this Field Safety Notice and affix it to the analyzer(s). Place the label(s) on the upper back panel of the analyzer(s) as shown in the images below, to remind users who are changing batteries of the importance of correct placement. Change batteries in a well-lit area.</p> <div data-bbox="403 853 1264 1279">

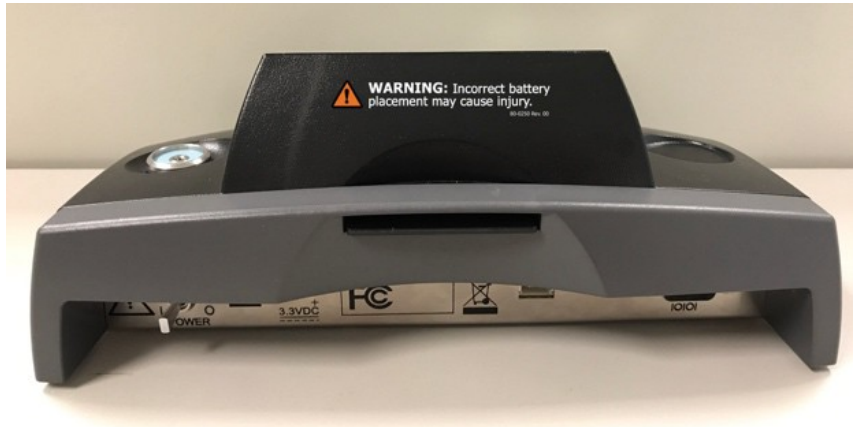
A photograph of the back of a grey LeadCare Plus Blood Lead Analyzer. A black warning label is affixed to the upper back panel. The label features a yellow triangle with a black exclamation mark and the text: "WARNING: Incorrect battery placement may cause injury." Below the analyzer, the back panel shows various regulatory markings including a triangle with a lightning bolt, a recycling symbol, "3.3VDC", "FC", and a triangle with a lightning bolt.</div> <p style="text-align: center;">LeadCare Plus®</p>
