**Urgent Field Safety Notice**  
**Repair of TIVITA Camera systems**  
**Reference number: 191007-01**

**Diaspective Vision GmbH**  
 Strandstraße 15  
 18233 Am Salzhaff

We hereby inform you about a product recall of our hyperspectral TIVITA camera systems. This letter contains all relevant information.

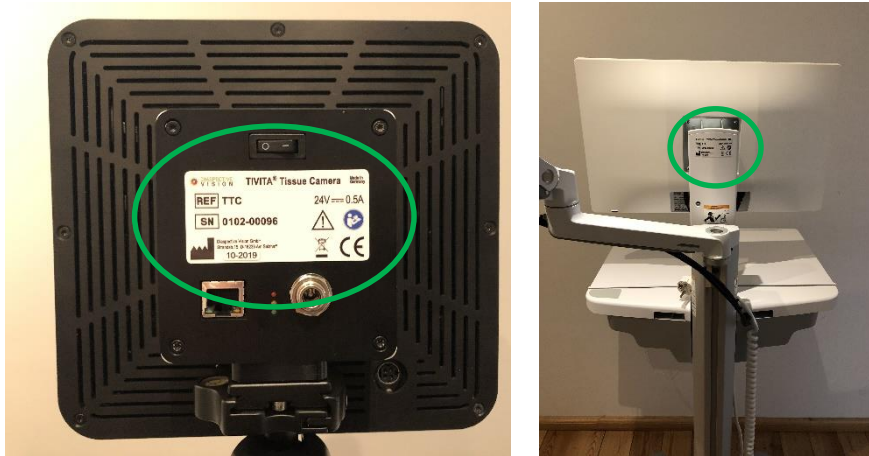
The serial numbers (SN) can be found on the back of the camera or on the back of the cart.

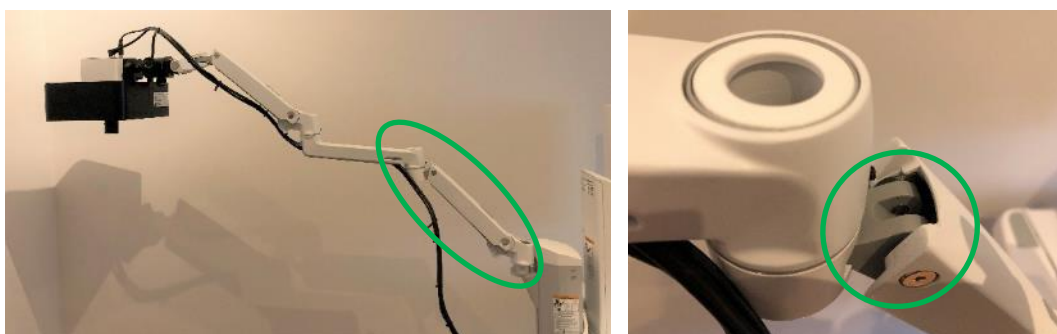
Figure 1: affected arm segment to be visually inspected

While using the TIVITA camera system, the upper end of the arm element broke, which is directly attached to the cart, causing the other two arm elements, including the camera, to fall down. If the arms are aligned in an unfavorable position, a lever is created which can lead to this defect.

In the worst case, a recurrence of such a defect may endanger the operator or the patient.

- Please check the affected arm segment (Figure 1) for possible damage before each use of the camera.
- If obvious damage (missing screw, broken arm, etc.) can be detected, please refrain from using the system and contact us.
- **If there are no recognizable defects, you can use the system as usual!**
- Please avoid the arm position shown in Figure 2.
- If possible, try to replace arm elements 1 and 2 (Figure 3).
- We are working on a new solution for this element. As soon as a working solution is available, we will inform you about the next steps.

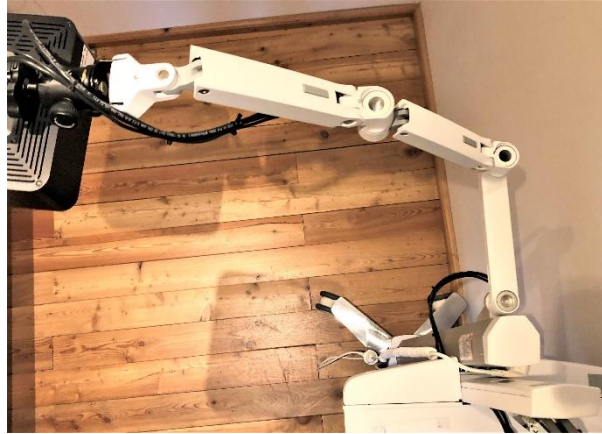
Figure 2: Please avoid this unfavorable positioning of the arms, as when adjusting the height of the camera in this position, high leverage forces act on the first arm element.

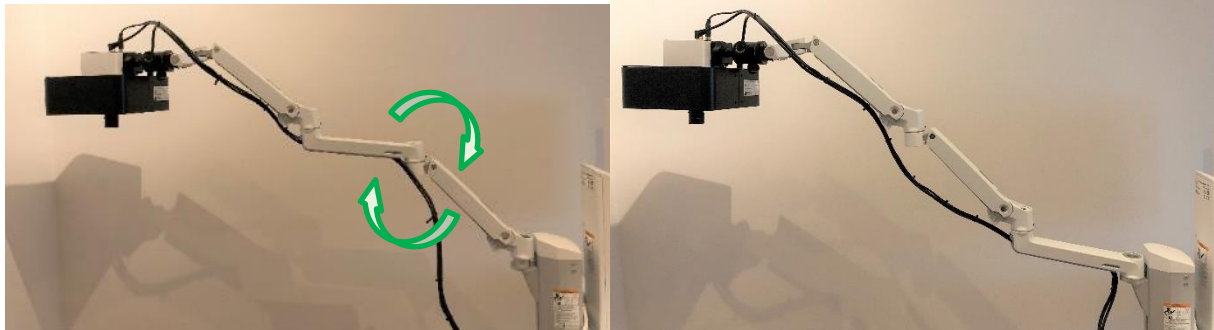
Figure 3: Exchange of the arm elements 1 and 2
