Urgent Field Safety Notice

Product Name: Patient Labels for Zimmer Products manufactured prior to March 2010
FSCA-identifier: FA-2012-01
Type of action: Notification
Date: 6 August 2012

Type of Device: Orthopaedic Implants manufactured by Zimmer GmbH, Winterthur (Switzerland) prior to March 2010

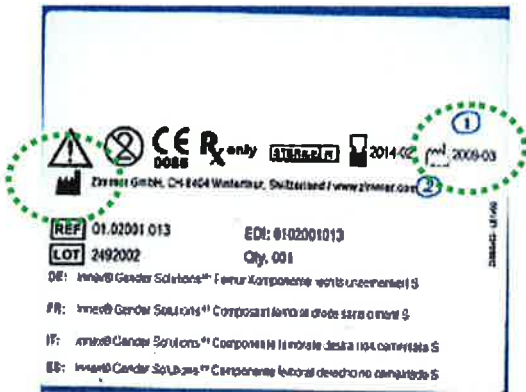
Figure 1, presented below, provides an example of a representative product label which indicates the Zimmer GmbH production site, following the "dark" production plant symbol, and also indicates the production date, following the "white" production plant symbol.

Figure 1: Example of a representative product label providing (1) is the manufacturing date (“white” production plant symbol), and (2) the manufacturing site (“dark” production plant symbol)

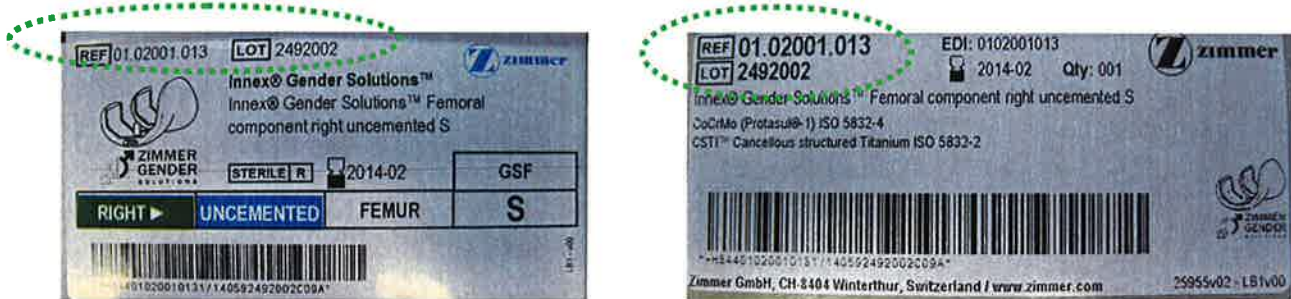
In rare cases, product information on the patient label, with respect to REF number/ LOT number might not coincide with the corresponding information on the product label.

While the information printed on the product label is always correct, the information on the patient label (in rare cases) may be wrong. Please note that, although it is unlikely that lots in your consignment delivered to you with manufacturing date prior to March 2010 are affected, we are issuing this letter as preventative information.

Figure 2: Example of the product label (left) and patient label (right)

Although the identified issue has been corrected at Zimmer GmbH, Winterthur, for products manufactured after March 2010, Zimmer recommends, as a general practice, **to always check the patient label by comparing its information** to the product label at the time of the surgery (please see figure 2).

As stated above, we ask you to **check the patient label by comparing its information** to the product label during the surgery.

- (1) Use whatever your institutional protocol is to **manually** record patient information using the correct information contained on the outer box label;
- (2) **Report** the error to Zimmer.
