Reference: FSCA-06-2019

This is to inform you of a product recall involving 1 lot of Baguera L Disc prosthesis. This recall has been initiated further to the detection of a mispackaging error.

Product information	<u>Manufacturer</u>		
Lumbar Disc Prosthesis Small D27 W35 H10 10° Ref LDP-10 SM 10-S Lot # 3-1185	SPINEART SA Chemin du Pré Fleuri, 3 1228 Plan-les-Ouates Switzerland		
	Contact name: Xavier de BUCHERE VP Global QS & RA Email Address: xdebuchere@spineart.com

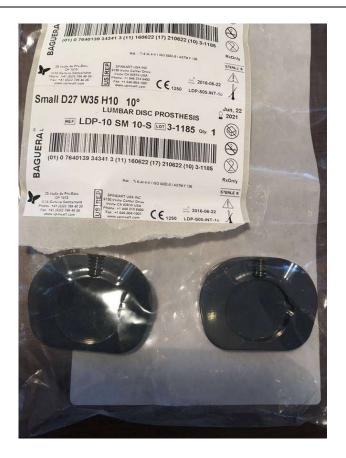
A mispackaging issue has been detected on 23.10.2019: 2 inferior plates were found in the packaging of LDP-10 SM 10-S instead of 1 inferior plate plus 1 superior plate. The picture below was provided.

The root cause has been found to be a wrong selection of plates when performing the packaging process. The operators placed 2 inferior plates in the same packaging instead of 1 inferior plate and 1 superior plate.

This is a human error. The rest of the lot could partially have the same issue.

1/ Identify locations of all parts from this lot.

2/ Contact the supplier in charge of packaging and open a NC to confirm the root cause and propose an efficient action plan.

- 1. Immediately review your inventory and quarantine concerned products if any.
- 2. You may have further distributed this product; please identify concerned customers and notify them at once of this product recall by using this document.
- 3. Collect and quarantine all products.
- 4. Sent back all products with the enclosed Response Form to Spineart Geneva (Chemin du Pré Fleuri 3, 1228 Plan-les-Ouates, Switzerland). E-mail: regulatory@spineart.com.
- 5. All returned products will be exchanged.

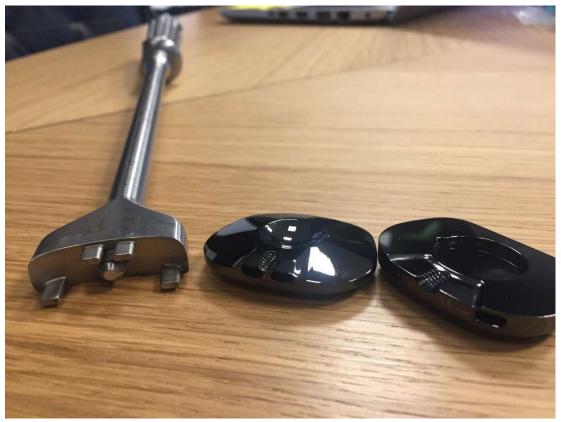
<u>Case 2</u>: 2 inferior plates were provided. The surgeon would then immediately detect the issue as it is not possible to assemble both inferior plates on the core, in the implant holder.

<u>Case 3</u>: 2 superior plates were provided. The surgeon would then immediately detect the issue as it is not possible to assembly both superior plates on the core, in the implant holder.

The tool is designed in a such a way that it is not possible to use it with 2 identical plates.

There is no risk for the patient as it is not possible to assemble 2 identical plates in the plate holder.
