URGENT: FIELD SAFETY NOTICE – PI-23-4673

Venovo™ Venous Stent System

Type of Action: Product Removal

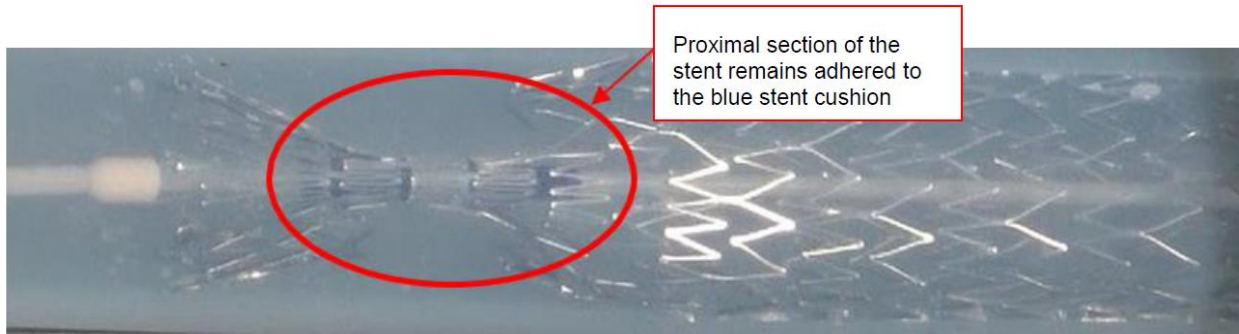
Based on internal investigation, the lots from Table 1 were errantly distributed and may result in exposure to known issues of potential delayed deployment and silicone embolisation in the event the proximal end of the **Venovo™ Venous Stent System** does not immediately expand upon deployment and remains connected to the stent cushion on the delivery system.

An illustration of the proximal section adhered to the stent cushion may be seen below in Figure 1.

Figure 1: Proximal end of the stent remains connected to the stent cushion material

The root cause analysis has evaluated the relationship of the stent cushion and its adherence to the stent as a potential contributing factor.

- Cease use of any unused affected **Venovo™ Venous Stent System**.
- Identify and quarantine all unused affected **Venovo™ Venous Stent System**.
- Make a note of the lot numbers and a BD representative will contact you on next steps.
- Complete and return the Customer Response Form **even if you no longer have any inventory remaining in your facility by 24th January 2023**.
- Circulate this notice to all those who need to be aware within your organization or to any organization where the potentially affected devices have been transferred.
- If you experience any issues with **Venovo™ Venous Stent System**, please report as a complaint as per your normal process.
