24 February 2023

Subject: **URGENT MEDICAL DEVICE FIELD SAFETY NOTICE (REMOVAL)**

Affected Product: Vanguard® Knee System, Posterior Stabilized Open Box Femoral

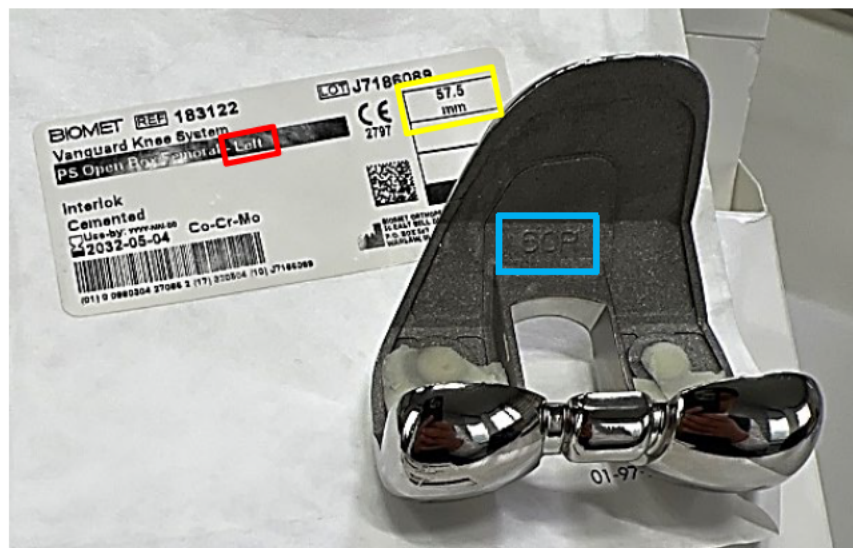
Example (picture on the left)

Label Item Number: 183122
 Label Lot Number: J7186089
 Label Size: 57,5 mm (in yellow box)
 Label Side: Left (in red box)

Actual Size: 60 mm
 Actual Side: Right
 On item identifiable as: "60R" (in blue box)

Biomet Orthopedics LLC is conducting a lot specific medical device Field Safety Corrective Action (removal) for the Vanguard Posterior Stabilized Open Box Femoral components listed in **Attachment 2 – Affected Product List** due to a commingle. Three complaints were received with no patient impact for packaging that was incorrectly labeled as the incorrect size, the incorrect side (right/left), or both. The incorrectly labeled products could have the potential risks as described in the table below.
