Reference: FSCA-01-2023

This is to inform you of a product recall involving the below mentioned products:

- Product Name: *LATERAL LUMBAR TI-LIFE PLATE*

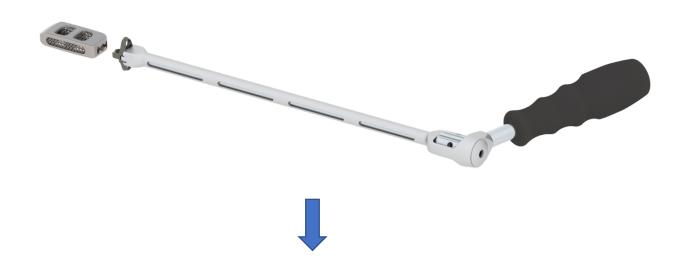
We have received 7 complaints since June 2022 on JULIET Lateral Lumbar Ti-Life Plates. These implants are Lumbar Interbody Devices indicated for intervertebral body fusion procedures.

These plates disassembled from the Screw Plate during the insertion into the cage as shown in the pictures below.

- b) Plate replacement: If the issue occurs, the surgeon should proceed as followed:
 - 1- Unscrew the Plate screw of the cage with the screwdriver,
 - 2- Scrap the current plate assembly,
 - 3- Use a new set of pre-assembled plate/screw (a minimum of 2 sets of pre-assembled plates/screws per size are part of the device listing). The cages are to be used with the corresponding plate or higher plate which means that a plate with the same heigh than the cage can be used but also a plate with higher height.
 - 4- In the case of 0° and 8° cages, a pre-assembled plate/screw is not mandatory as described in the surgical technique
