## URGENT FIELD SAFETY NOTICE

GEHC Ref# 34095-A

RE: **CARESCAPE R860 ventilator Inspiratory Safety Guard (ISG) – Potential for loss of ventilation**

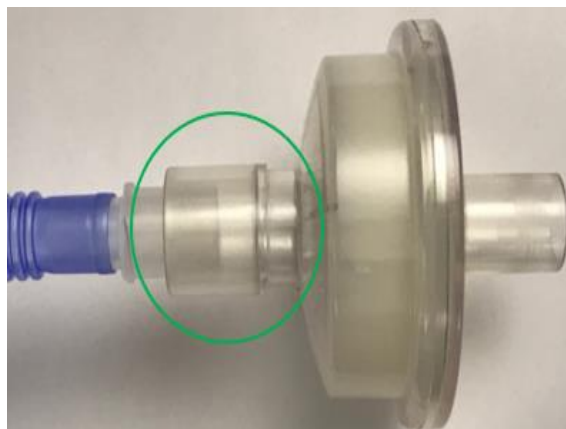
Figure 1: **CORRECT** Inspiratory Safety Guard (ISG)

You may continue to use your ventilator with the ISG outlet if the 15mm female conical connector is inspected for a secure fit in the location indicated below where engagement resistance would normally occur (see figure 1).

15 MM - Breathing Circuit

**Note:** An ISG currently in use with Adult or Pediatric patients utilizing 22mm male circuit connection are not associated with this issue and are safe for continued use after inspection of both inlet and outlet issues have been completed. When systems are no longer in use, inspect for 15mm incorrect connection per the instruction in Figure 1.

The ventilator Inspiratory Safety Guard (ISG) may disconnect from the breathing circuit pathway. As a result, the disconnection could create a loss of ventilation which may lead to inadequate oxygenation for patients, increasing the possibility of hypoxia. There have been no reported injuries as a result of this issue.

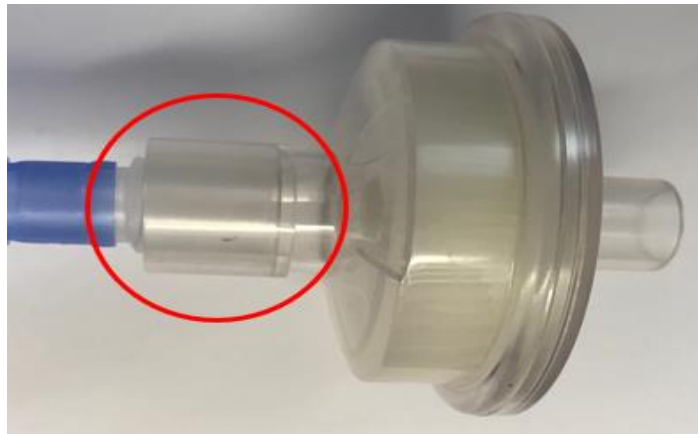
Figure 2: **INCORRECT** Outlet Inspiratory Safety Guard (ISG)

If the male connector looks like Figure 2, and freely slides up the entire length of the ISG female port, this indicates an incorrect ISG. In order to use the incorrect ISG you will need to use an adapter to ensure a pneumatic seal. If an adapter is not available, the ISG cannot be used for the 15mm connection.

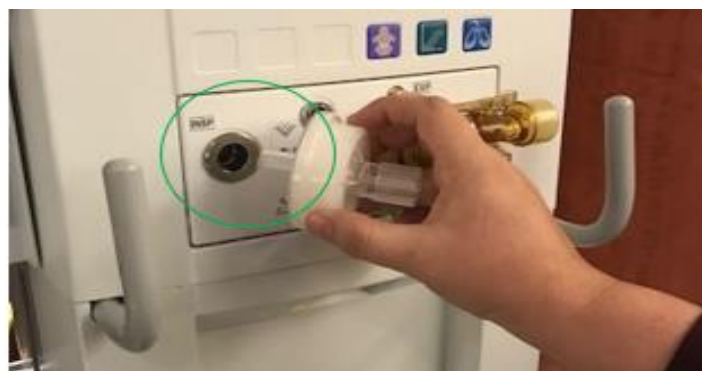
Figure 3: Ventilator Outlet Port with the ISG inlet connection

You may continue to use your ventilator with the ISG inlet if the connector engages in the ventilator Outlet Port with a secure fit in the location indicated below. (see figure 3).

**Note:** The metal ventilator outlet port is correct.

**NEW ISSUE:** The ventilator Inspiratory Safety Guard (ISG) may disconnect from the ventilator outlet port. As a result, the disconnection could create a loss of ventilation which may lead to inadequate oxygenation for patients, increasing the possibility of hypoxia. There have been no reported injuries as a result of this issue.

- a. Ensure all breathing circuit conical connectors fit securely during initial breathing circuit assembly.
- b. Follow the instructions for use outlined in the User Reference manual 2065490-001 section 4: Setup and Connections.
- c. Run a SYSTEM CHECK after patient circuit connection are made with all applied accessories outlined in Section 6 of the User Reference manual prior to connecting the patient.
- d. Set all alarms appropriately to ensure accurate and timely detection of sudden patient disconnect.
