URGENT – Medical Device Correction Field Safety Notice

Philips V60 Ventilators User Interface RP-Kits May Be Impacted by Unresponsive Touchscreen

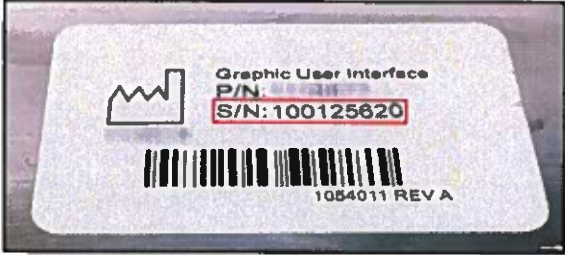
<p>An enlarged view of the label on the back of the device. The label contains the following information: a Philips logo, the text 'Graphic User Interface', 'P/N: 1054011', 'S/N: 100125620' (highlighted with a red box), a barcode, and '1054011 REV A'.</p></div> <p data-bbox="748 1831 1123 1862">Figure 3: Label Enlarged View</p>

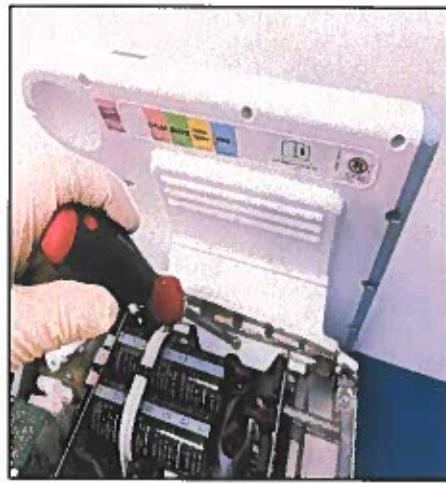
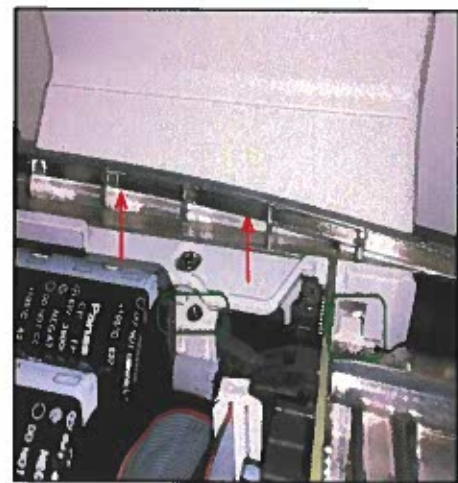
- b) Loosen the UI Rear Bezel retention bracket screw, taking care not to separate the captive nylon washer which keeps the screw captive to the bracket when the bracket is lifted to the unlocked (upward) position. (See **Figures 7 and 8**)

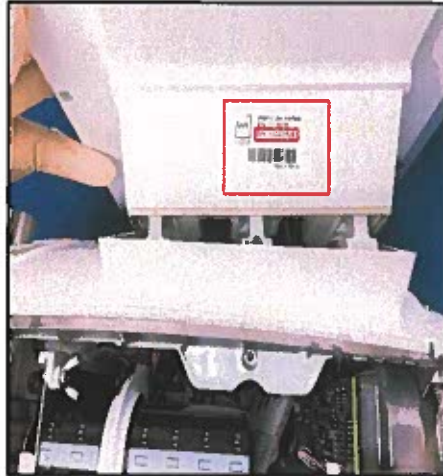
Figure 10

- d) Gently pull the UI Assembly away from the Front Panel just far enough to reveal its PN/SN and verify if the serial number indicated on its label, matches the serial number of the affected UI Assembly RP-Kit indicated in the **AFFECTED PRODUCTS** section above. (See Figure 10)

- e) If serial number indicated on the UI Assembly currently installed in the ventilator **DOES NOT MATCH** the serial number of the affected UI Assembly RP kit indicated in the "Affected Product" section, reassemble the UI Assembly to front panel. Ensure cables are properly seated and were not dislodged/disconnected during the process. Reinstall the top cover and side panels, and conduct the following tests in accordance with the V60 Service Manual.

- f) If the serial number indicated on the UI Assembly currently installed in the ventilator **MATCHES** the serial number of the affected UI Assembly RP kit indicate in the "Affected Product" section, list the serial number of the **VENTILATOR** and the **UI Assembly** on the "Acknowledgement and Receipt Card" attached below. Upon receipt of the "Acknowledgement and Receipt Card," by Philips, appropriate action will be taken by a Philips authorized representative to replace the touchscreen in the ventilator containing the affected User Interface Assembly.
