URGENT - FIELD SAFETY NOTICE

Subject: 575777 Pin on Transport Guard of Cardiohelp-i can come loose

Affected product: Cardiohelp-i (article number 701048012)
Cardiohelp-i (article number 701072780, US Variant)

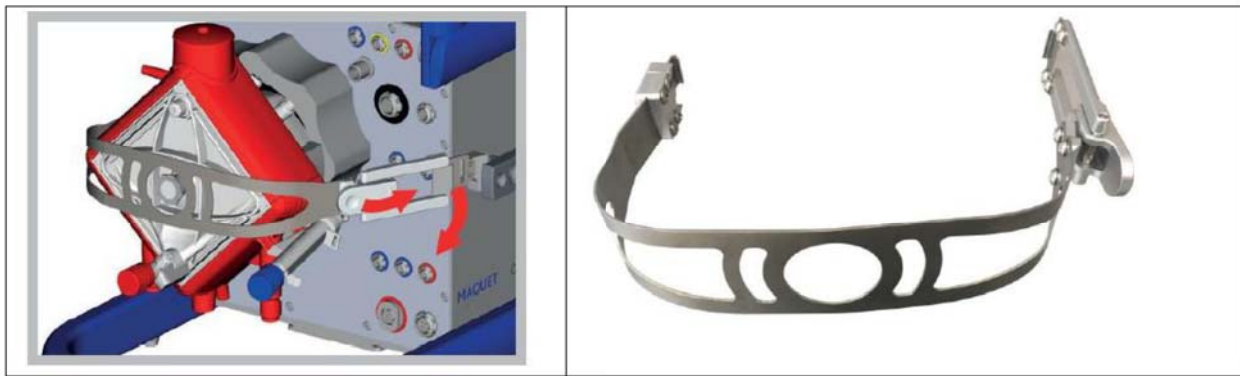
Picture 1 Transport Guard with Disposable

Maquet Cardiopulmonary GmbH has determined during the End of Life testing of a Cardiohelp-i, that the cylindrical pin in the upper part of the Transport Guard can come loose. The Transport Guard is an accessory of the Cardiohelp-i and secures the oxygenator to the drive during inter-hospital transportation or intra-hospital transportation if no Sprinter Cart/ Sprinter Cart XL is used.

- Corrective Action:**
- The Transport Guard within the affected Cardiohelp-i units with the serial numbers mentioned above will be checked by the Getinge authorized representative and replaced by a new one if required.
 - Pending the replacement of the Transport Guard, please check if Transport Guard can be opened and the mentioned pin is not loose.

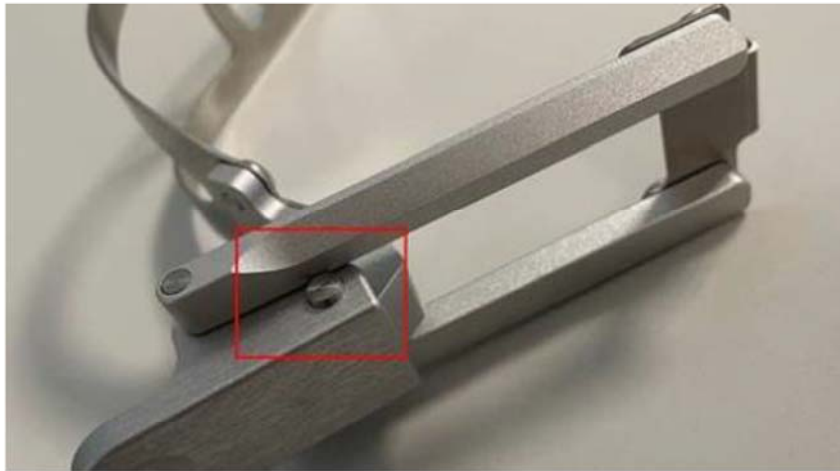
- If the locking mechanism jams, it may result in a failure to open the Transport Guard if/ when necessary, see picture 1.

Picture 2 Jamming of the Transport Guards due to loosened cylindrical pin. Opening of the Transport Guard is not possible.

If emergent opening is necessary while the Transport Guard is jammed, this can result in insufficient patient support resulting in ischemia.

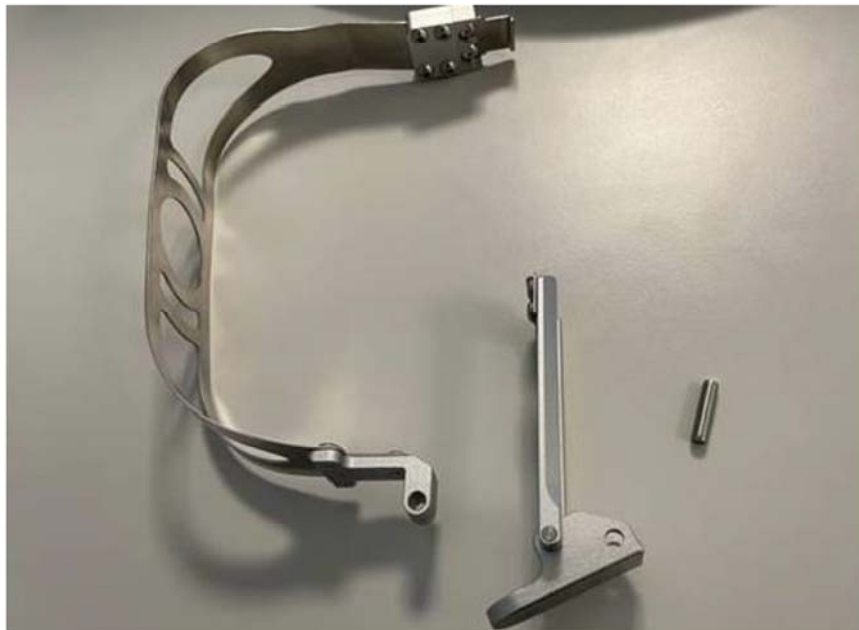
- If the locking pin comes loose from the assembly of the Transport Guard, it may result in disassembly of the Transport Guard during use, see picture 2.

Picture 3 Disassembly of the Transport Guard due to loosened cylindrical pin.

If the Transport Guard disassembles during use it does not fulfil its function to hold the HLS module in the event of the Cardiohelp-i being dropped on the floor.
