**URGENT FIELD SAFETY NOTICE****Manufacturer SRN:** DE-MF-000020091**FSCA Reference:** FSCA 745922 - HLS & PLS Set - potentially compromised sterile barrier**FSN Type:** Update**Affected Products:**

The HLS Set Advanced and the PLS Set are intended for use in an extracorporeal circulation for pulmonary and/ or cardio-circulatory support.

**1. Inspection of Intellipacks (plastic packaging component of the product)**

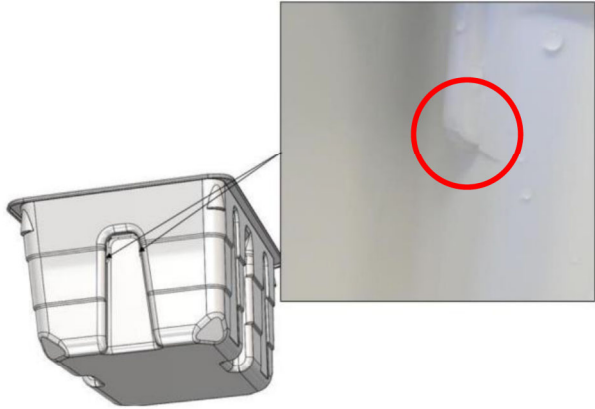
<p>Error case 1 (HLS+PLS): Damage on primary packaging (intellipack) caused by production process failure:</p> <p>In course of sterile barrier system integrity tests, MCP has determined a <u>defect (visible cracks)</u> in the intellipack packaging tray that can occur during production. <u>Cracks</u> may compromise the integrity of the sterile barrier of the HLS/PLS sets.</p> <p>Corrective Action implemented on 2023-03-07: Change of production process and introduction of 100% inspection.</p>

<p>Area on the intellipack packaging tray where the failure was detected with crack</p>

- Perform a visual inspection of the primary packaging, check for visible damages (cracks, holes etc.) in the packaging according to error case 1 (HLS + PLS) and 2 (HLS) described above. In case of visible damages in the packaging, do not use the product and return for replacement or credit note. Please refer to Annex II for a detailed instruction on how to check your products for the respective error cases.

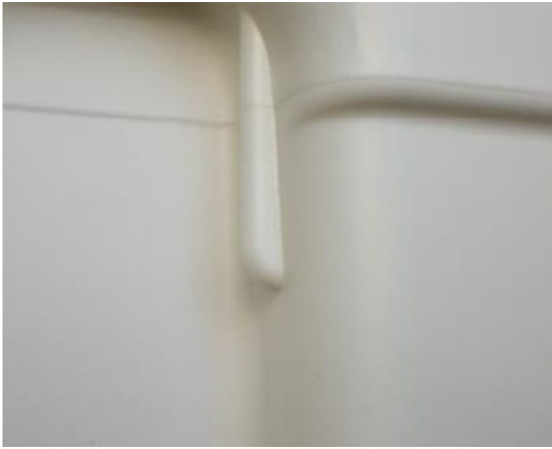
<p><u>Conform:</u> Undamaged, unstressed intellipack packaging tray</p>

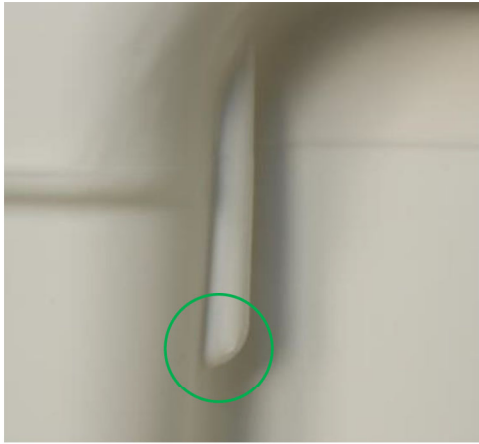
In the meantime, MCP has conducted further investigation into the error cases, specifically, the "white stress marks". All samples used passed through a real transport route and were tested for integrity afterwards. The tests have shown no evidence that the "white stress marks" have a negative impact on sterility. In addition, none of the retrospectively inspected sets returned from customers have shown any breaches in sterile barrier. In conclusion, there is no increased risk for patients or users due to the "white stress marks".

<p><u>Conform:</u> White stress marks on intellipack packaging tray</p>

Following this investigation, MCP has updated Annex II Instruction for visual inspection to define products with "white stress marks" as conforming and suitable for use.

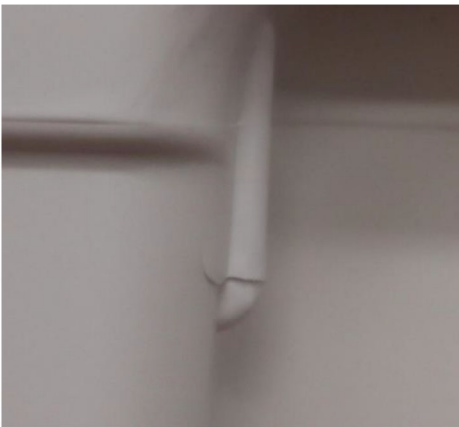
<p><u>Not conform:</u> Crack in intellipack packaging tray</p>

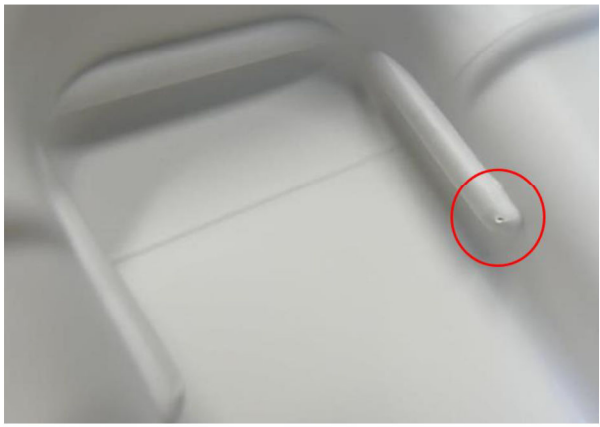
<p><u>Not conform:</u> Hole in intellipack packaging tray</p>

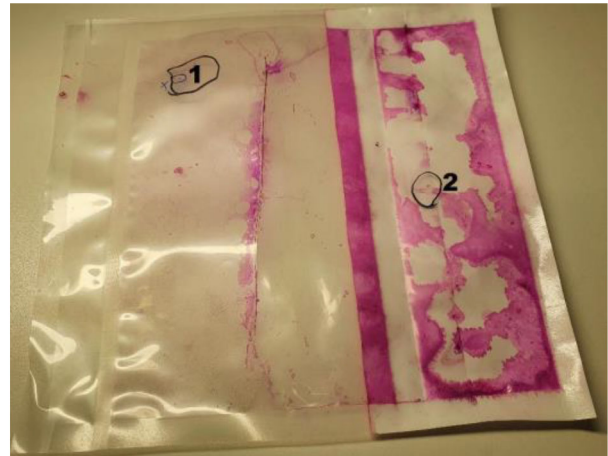
Damage of the component Tyvek pouches. Combination of production process error and transport stress can lead to perforation of the secondary packaging. This defect may compromise the integrity of the secondary sterile barrier of the HLS sets.

(The picture is merely for visualization of ink testing under laboratory conditions and was included for completeness purposes.)

Corrective Action implemented on 2023-03-07:  
Change of packaging process and implementation of 100% inspection.

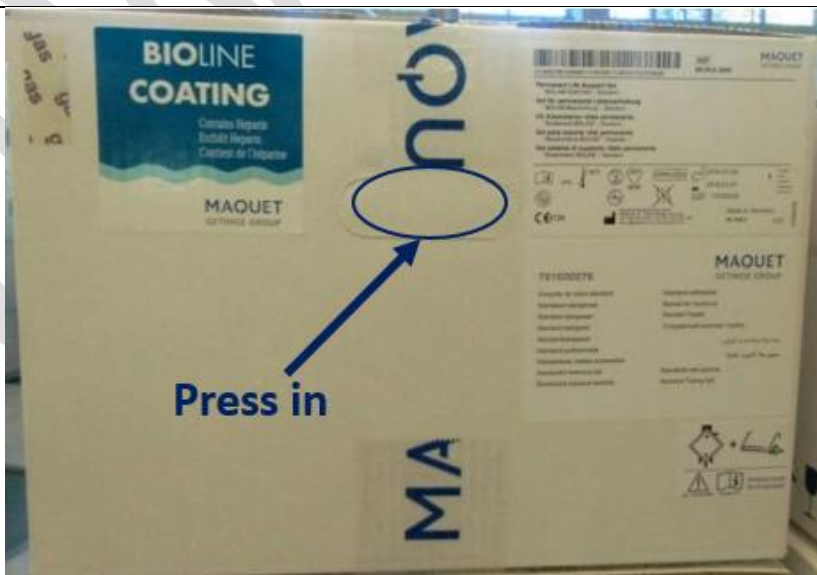
Before use, the holder for safety plates of the Intellipacks must be checked for possible damage.

For this purpose, the handles present in the outer packaging must be pressed in. As a result, the holder of the Safety plate is visible on the Intellipack.

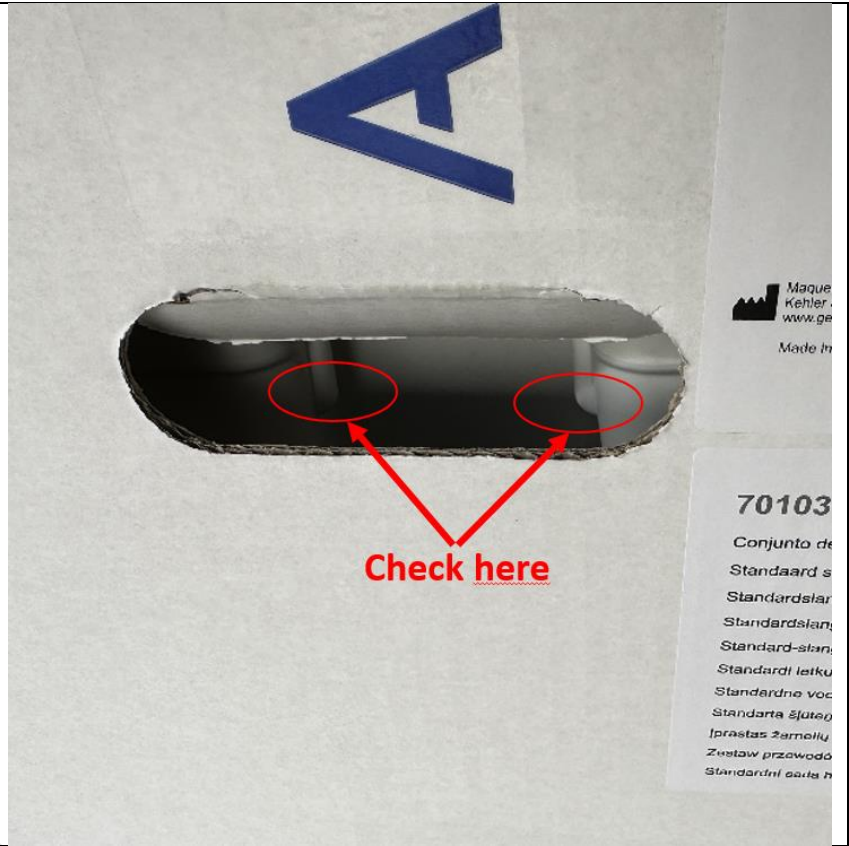
Use a commercially available LED flashlight during the investigation to get a better view on the holder of the safety plates!

Note: The holders for the safety plates are only present on one side.

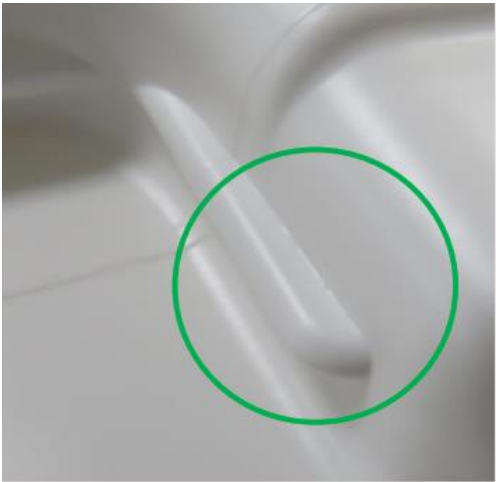
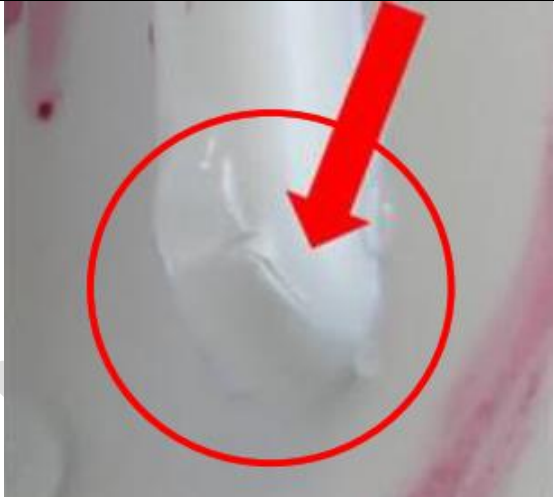
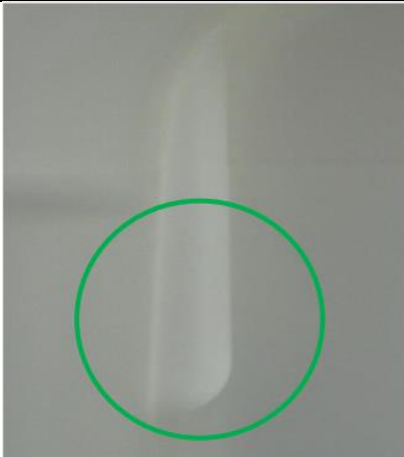
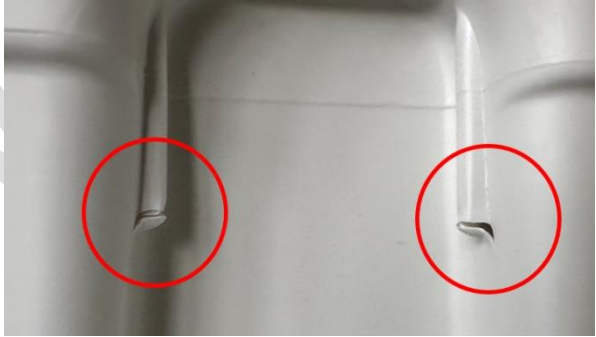
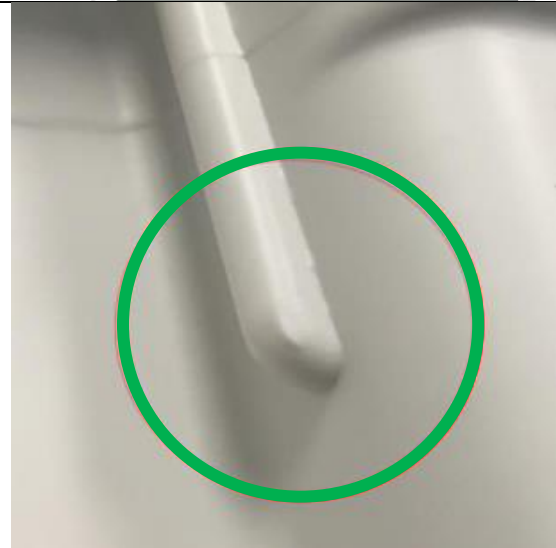
2. Exemplary pictures of conforming and not conforming products		
Material is undamaged (pictures 1 and 2) or shows white stress marks only (picture 3) and can be used	Material is damaged (with a visible breakthrough) and cannot be used	
1
