URGENT: MEDICAL DEVICE RECALL

Research Instruments is voluntarily recalling the power supply cable for the **Integra 3™ micromanipulator**. Research Instruments internal testing has discovered a minor materials fault with the power supply cable (2-54-031). Our records show the affected products are installed at your facility.

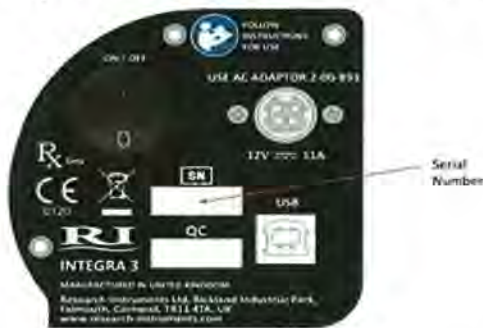
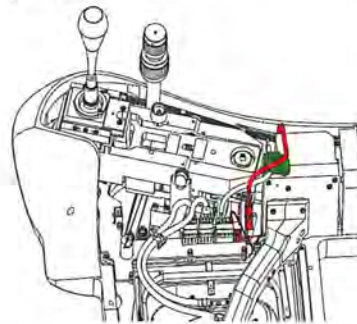
In rare instances, this cable may cause the loss of power to the heating control of the Integra 3 and the temperature function being disabled. In order to mitigate any chance of down time for your Integra 3 micromanipulator, we have already replaced your power supply cable during a scheduled service visit and you can therefore consider this correction complete.

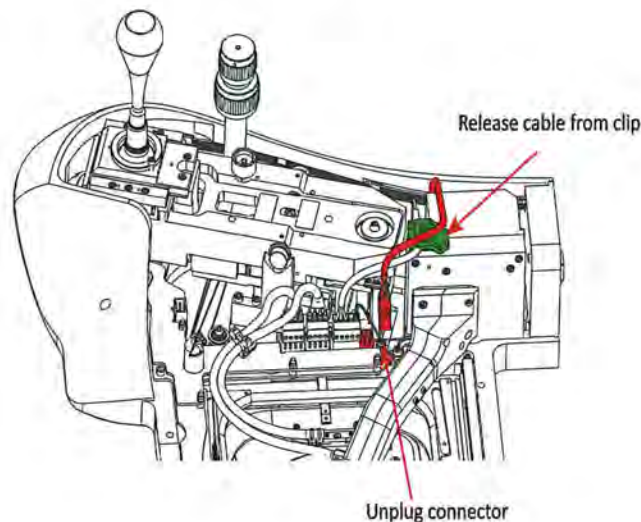
In rare instances, the power supply cable may cause the loss of power to the heating control of the Integra 3 and the temperature function to be disabled. In order to mitigate any chance of down time for your customers' Integra 3 micromanipulator, we recommend this power supply cable is replaced by one of your trained technical engineers. We anticipate this correction will take approximately 10 minutes depending on accessibility.

To initiate the replacement of the power cable, please follow the steps below:

1. Acknowledge receipt of this letter by completing the attached **Acknowledgement and Receipt Form**
2. Review your sales and traceability records to identify users of the Integra 3 model. Please note, you are contractually obligated to maintain traceability records for the sale of all RI products and this information should be easily available.
3. Promptly contact all Integra 3 users and inform them of this Correction Notification
4. Promptly arrange the replacement of the cable on each Integra 3 by one of your trained technical engineers within 3 months of the date of this letter.
5. Record each replacement on the Product Correction Completion Form (PCCF) enclosed. The serial number of each Integra 3 can be found on the back panel.
