Olympus reference: QIL FY24-EMEA-29-FY24-EMEA-14 White Tape

URGENT FIELD SAFETY NOTICE

Product Return to Olympus Repair Center for additional Inspection

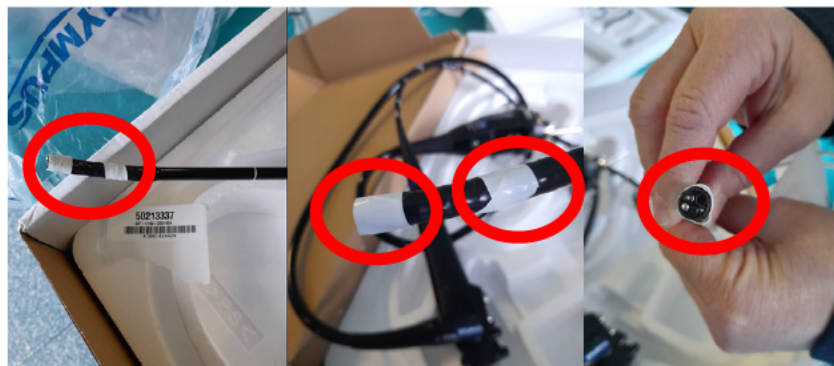
Wrong – White Tape

Olympus recently received complaints indicating that the insertion tube of a repaired endoscope was wrapped with white tape.

This white tape is used during the repair process to protect sensitive parts of the endoscope from damage, (scratches and dents). It is to be removed during final

inspection prior to being returned to the customer for patient use. The endoscope is not intended to be used on a patient with this white service tape attached.

If not removed, the white tape could potentially damage the mucosal tissue and lead to bleeding. Additionally the tape could fall off during examination, fall into the patient's digestive tract and potentially be retained. If the tape slips off during insertion into the oral cavity it may cause aspiration, respiratory distress, and asphyxia. Reprocessing of an endoscope with the white tape attached might lead to insufficient disinfection with the potential for risk of contamination and subsequent patient infections.

You may have detected the white tape in the meantime and removed it. In an abundance of caution, Olympus recommends the return of your product for an additional inspection to ensure that your endoscope is meeting our repair and inspection specifications and standards.

1. Carefully read the content of this Field Safety Notice.
2. Inspect your inventory to identify the device(s) **XXXXXXXX** with serial number(s) **XXXXXXXX**.
3. If you find the product wrapped with white tape at the distal end or had found and already removed it, segregate the device and cease usage with immediate effect.
3. Contact your Olympus customer service representative by **[Regional contact]**. Olympus will issue a Return Material Authorization to return any affected product at no charge.
