Field Safety Notice

Notification regarding a voluntary product recall

Reference R-20210711-2/ R-20210711-3

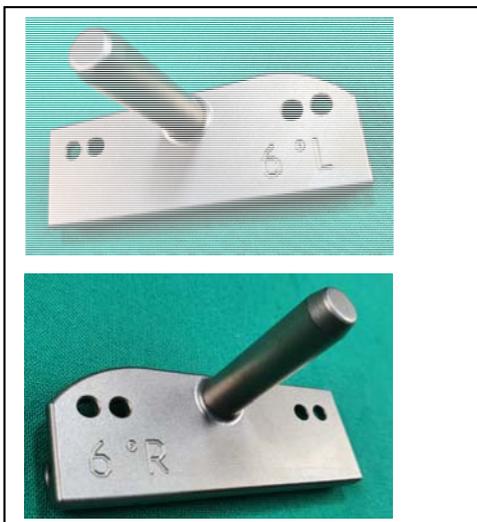
Due to a customer feedback it became aware that a weld seam was insufficiently executed during the manufacture of the affected valgus plates. After multiple intended uses, the stability of the welded holder on the femoral site, is not always guaranteed and can become loose and thus may protrude.

Fig. 1: valgus plate with welding seam

- Please ensure that within your organization all users of the above-mentioned products and all other persons to be informed, are made aware of this field safety notice.
- Please check your stock immediately and ensure that the affected products are no longer used.
- Please return all affected products address stated in the following. You will immediately receive a replacement free of charge.

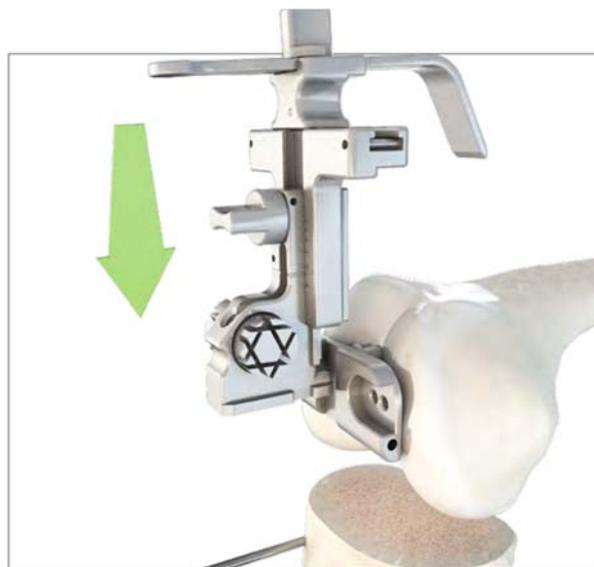
This can lead to sticking of the flexion gauge when it is inserted into the valgus plate during instrumentation. In the worst case, the flexion gauge cannot be inserted into the valgus plate.

Fig. 2: Insertion of flexion gauge in the valgus plate
