## Urgent Safety Notice

Precautionary replacement of motors on older treatment tables

**Re:** THERA treatment tables from FREI AG

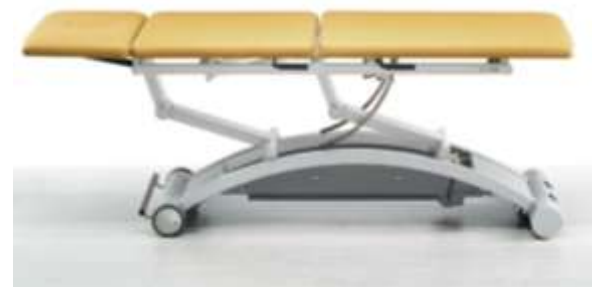
THERA treatment tables with article numbers:

Standard: 8.5200.03 ; 8.5200.04 ; 8.5200.10  
Universal: 8.5205.00 ; 8.5205.03 ; 8.5205.04 ; 8.5205.10  
Manual: 8.5210.00 ; 8.5210.03 ; 8.5210.04 ; 8.5210.10  
pro: 8.5207.04 ; 8.5207.05 ; 8.5212.04 ; 8.5212.05  
Edition: 8.5206.03 ; 8.5206.04 ; 8.5206.05 ; 8.5211.03  
Vojta: 8.5215.00 ; 8.5215.03 ; 8.5215.04

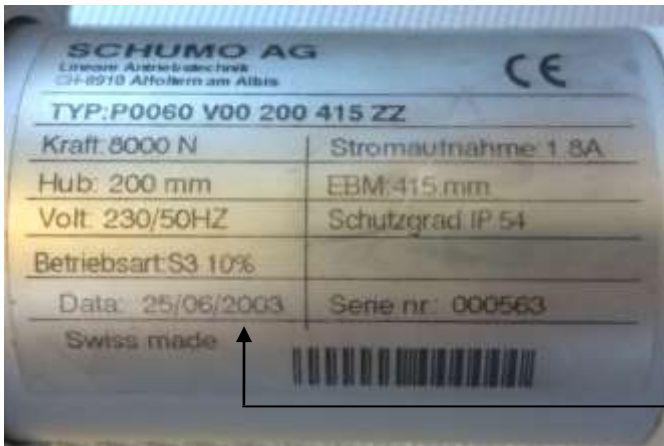
Example of a motor type plate:

Check the year of manufacture of all adjustment motors on your treatment tables. Motors older than 10 years should be replaced as a precaution. The age of the motor is indicated on the type plate of the motor or on the treatment table.

Year of manufacture

If this inspection fails or cannot be carried out, please stop using these treatment tables and contact FREI AG. We are happy to assist you with any questions regarding this measure. The age of the motors and thereby the replacement interval must be checked in the course of the recurring safety inspection.
