## Urgent Safety Notice

Precautionary replacement of motors on older treatment tables

**Re:** GYM and GYM X treatment tables from FREI AG

**From:** FREI AG Aktive Reha-Systeme, Am Fischerrain 8, 79199 Kirchzarten, Germany

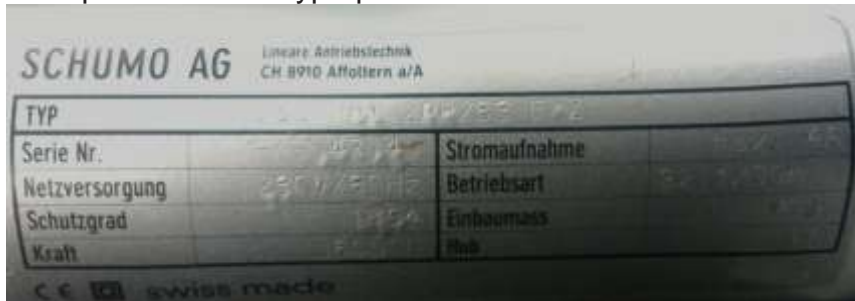
Example of a motor type plate:

Check the year of manufacture of all adjustment motors on your treatment tables. Motors older than 10 years should be replaced as a precaution. The age of the motor is indicated on the type plate of the motor or on the treatment table.

Without year of construction:  
very old engine

If this inspection fails or cannot be carried out, please stop using these treatment tables and contact FREI AG. We are happy to assist you with any questions regarding this measure. The age of the motors and thereby the replacement interval must be checked in the course of the recurring safety inspection.

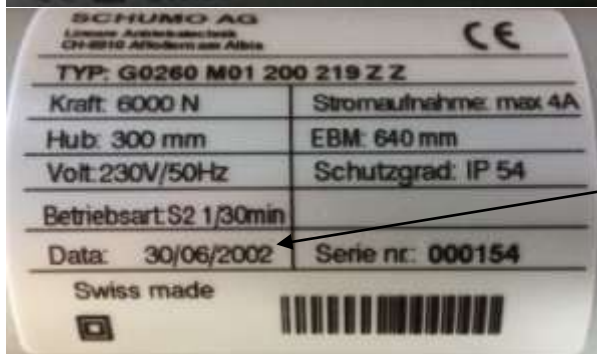
Year of construction 2002- today 16 years old
