Urgent product safety information

200799955

Karl Storz: Low pressure tube, CO2

2020-02-26

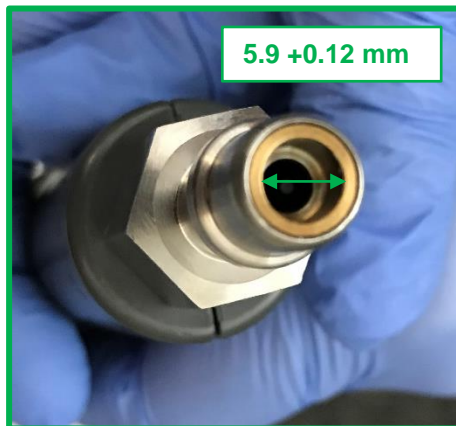
Figure 1: Correct inner diameter
5.9 +0.12 mm

1. Check your stocks immediately. Locate all potentially affected products and check their inner diameter (see Figure 1). The article number is located on the respective product. Faulty products must be returned to Karl Storz SE & Co. KG. Contact your sales representative/distributor to arrange for a replacement.
2. Forward this product safety information to any internal parties who may be affected.

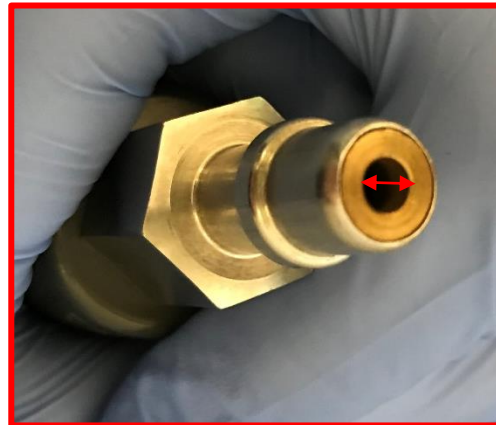
Karl Storz has been informed that the low pressure CO₂ tubes stated above may contain an incorrect component in the connecting plug. The diameter of the component deviates from the specified dimension.

Inadvertently connecting the CO₂ plug to an O₂ connection point may result in a flow of gas under certain circumstances. The CO₂ plug will not engage fully in the O₂ connection point; however, it is possible that, if a misaligned connection is established and tension is therefore exerted on the tube, the plug may become wedged in the connection point, resulting in a flow of gas. If connected correctly, the plug would have to be pushed all the way into the O₂ connection point in order to establish a constant gas flow.

Figure 2: Incorrect inner diameter
