**URGENT - Field Safety Notice
DigitalDiagnost Release 3**

Missing protective cover on Control Handle for Ceiling Suspension

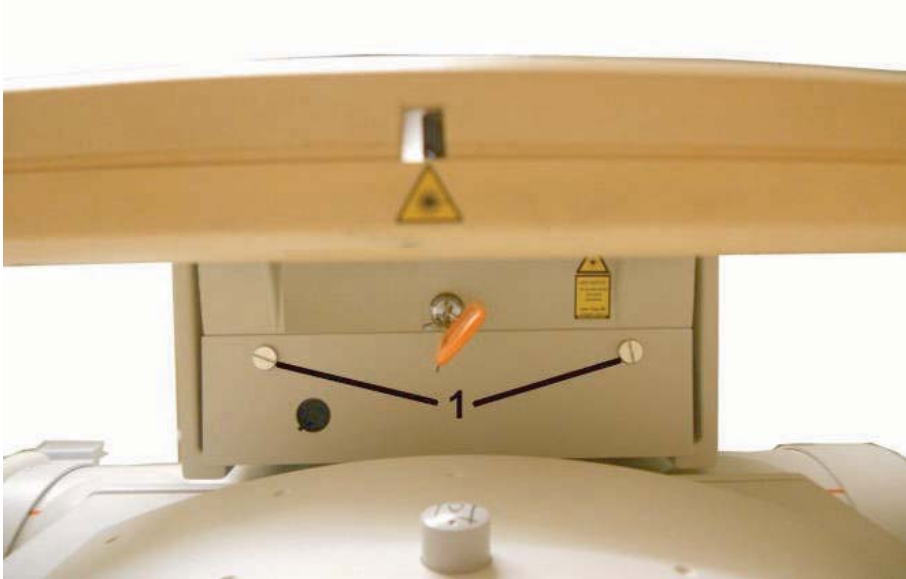
AFFECTED PRODUCTS	DigitalDiagnost Release 3
PROBLEM DESCRIPTION	<p>During an in-house inspection, some systems of DigitalDiagnost Rel.3 were found to be missing a small, metal protective cover on the bottom side of the control handle for the ceiling suspension. This exposes electrically live parts on the printed circuit board of the control handle to the potential for direct contact. The live voltage that is exposed to potential contact is only 25 volt, but it is a deviation from the IEC standard.</p>

<p style="text-align: center;">Bottom view of Control Handle with mounted protective cover.</p>
HAZARD INVOLVED	There is a potential low risk for harm if the user or patient places his or her hand in the open slot where electrically live parts may be touched.
HOW TO IDENTIFY AFFECTED PRODUCTS	<p>This correction applies to the following affected units of DigitalDiagnost Rel. 3 systems, produced between June 2011 and October 2011: Type number - 9890 010 83903 Serial numbers - 11000001 to 11000028.</p> <p>The system type number and serial number can be found on the label attached to the lower end of the ceiling suspension telescope. (Refer to the Instructions for Use for further description of the labeling location.)</p> <p>Please note: This cover may not be missing from all systems.</p>

ACTION TO BE TAKEN BY CUSTOMER / USER	Do not place your hand in the open slot below the Control Handle and ensure that no patient places his/her hands there.
ACTIONS PLANNED BY PHILIPS	Philips has issued a Field Change order instructing Service Engineers to check affected systems and install the cover where it is missing free of charge.
FURTHER INFORMATION AND SUPPORT	If you need any further information or support concerning this issue, please contact your local Philips representative: <Philips representative contact details to be completed by the KM / country>
